SURVEY & DOCUMENTATION

Our Pleasant Hill Commercial Study focused on three main areas of the City: Retail Centers, Streetscape Conditions, and Gateway Monuments.

Retail Assessment Introduction

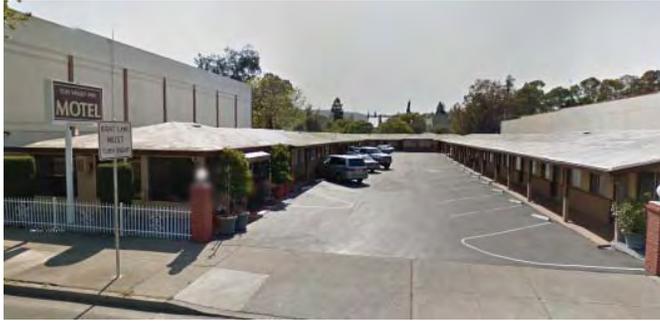
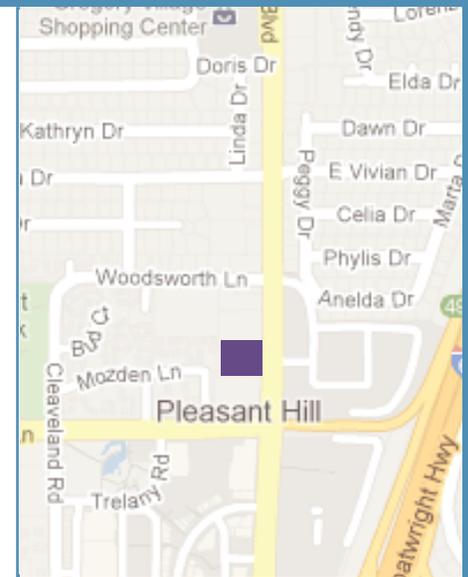
Retail Area Location

Edges/ Boundaries: Small decorative fences and ornamental sculpted hedges.

Landscaping: Small hedges and ornamental fences in addition to a smattering of potted plants.

Tenant Signage: One monument sign on a pillar and an externally lit box wall sign.

Building Facades: Well maintained but traditional.

Paint: In good condition.

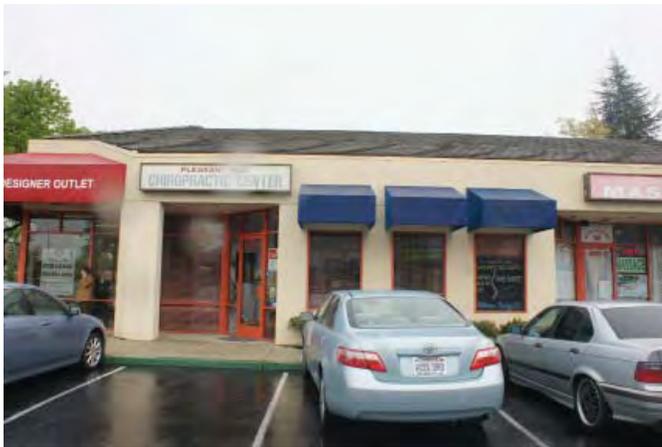
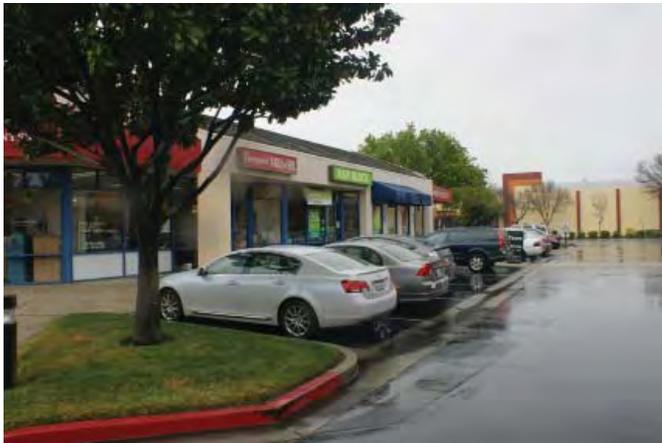
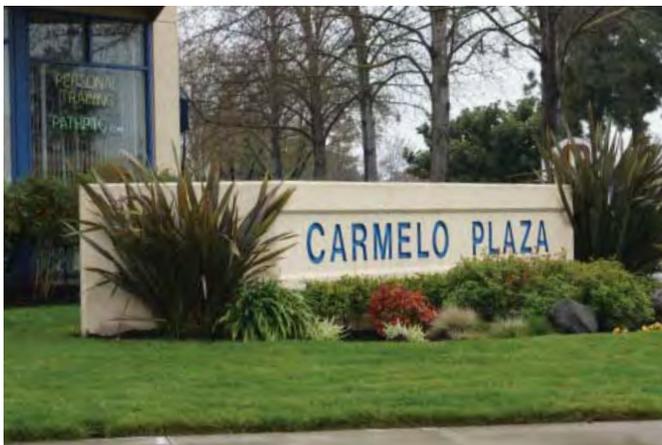
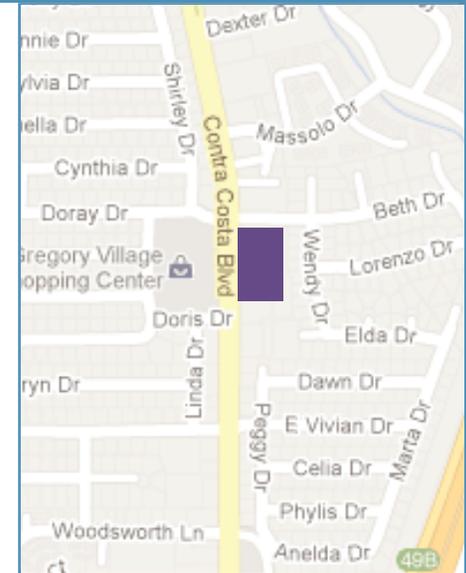
Retail Area Location

- Edges/ Boundaries:** Well defined and landscaped.
- Adjacent Influence:** Large strip mall (Grocery Outlet) across Contra Costa Blvd.
- Trash Enclosures:** In back, decent condition.
- Patios:** Plenty of room, no obvious outdoor seating.
- Entrances from Road:** Well marked, easy access.
- Pedestrian Access:** Wide walkways- easily navigated.
- Landscaping:** Trees and Shrubs around parking and pads.
- Site Signage:** Large, landscaped monument sign on corner, small monument sign with tenant listing inside plaza. Small sign could use improvements.

- Tenant Signage:** Large interior lit box signs need a redesign.
- Building Facades:** Stucco columns and overhangs, some building pads.
- Paint:** Good.
- Storefronts:** Some recessed storefronts and lots of glazing throughout. Too much window blockage in most.

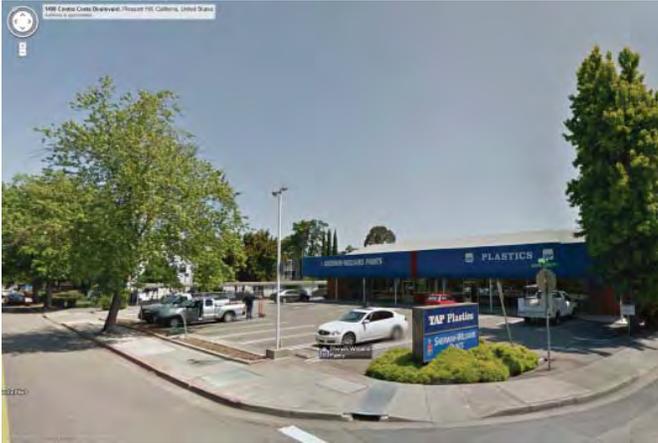
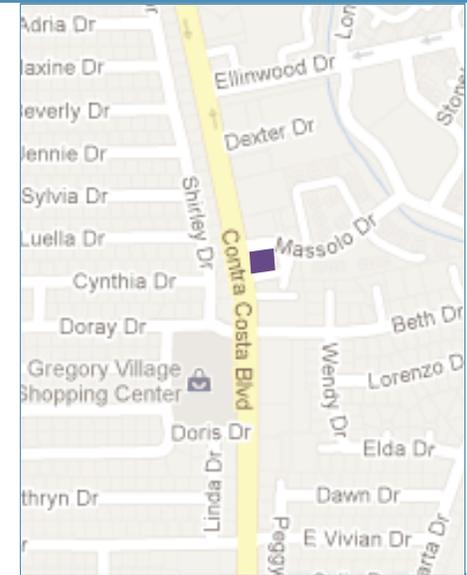
Retail Area Location

Landscaping: Mature trees and a few shrubs here and there. Empty bark-filled landscaping bed along street.

Site Signage: Corner monument sign--nondescript.

Building Facades: In good repair, but the awnings are very strangely designed.

Storefronts: Awnings could use a redesign.

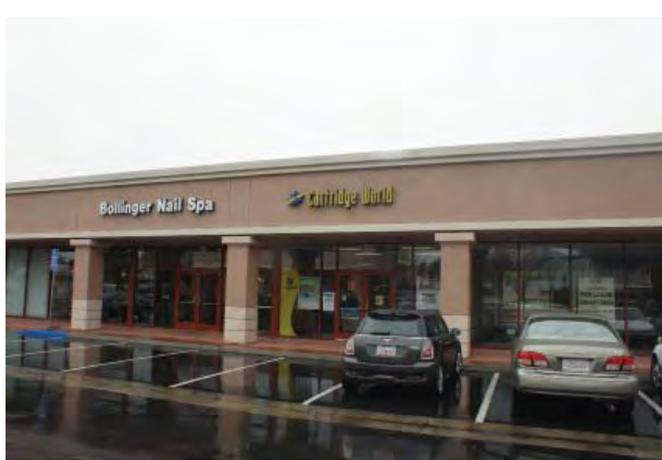
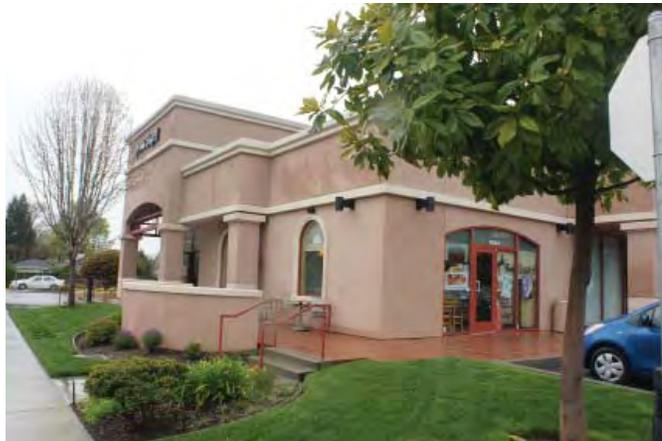
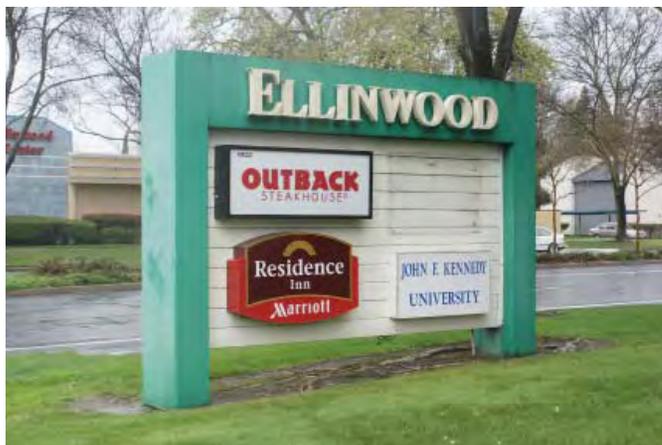
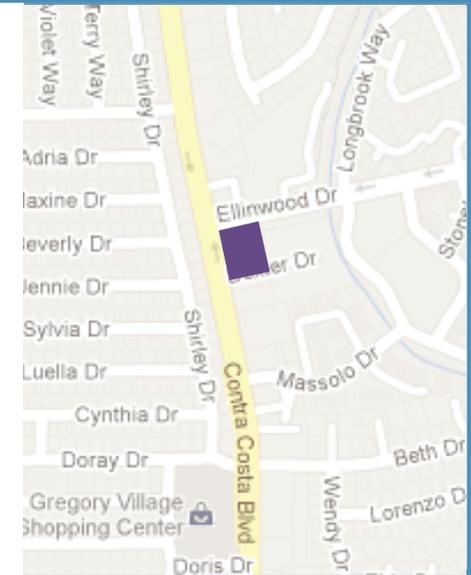
Retail Area Location

Site Signage: Unattractive and unmaintained monument sign on corner needs replacing. Smaller monument sign at side entrance.

Building Facades: Well filled out on Contra Costa side, slightly empty looking on back. In great repair.

Storefronts: Glass and aluminum, lots of glazing and in good repair.

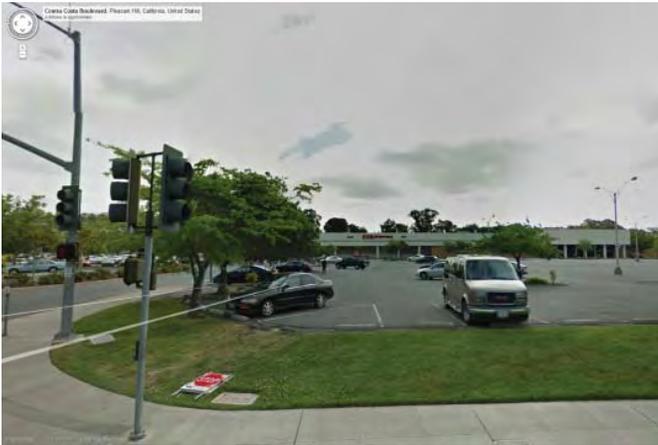
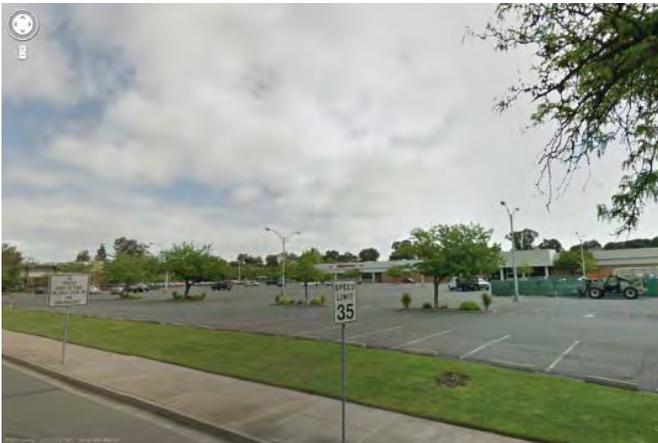
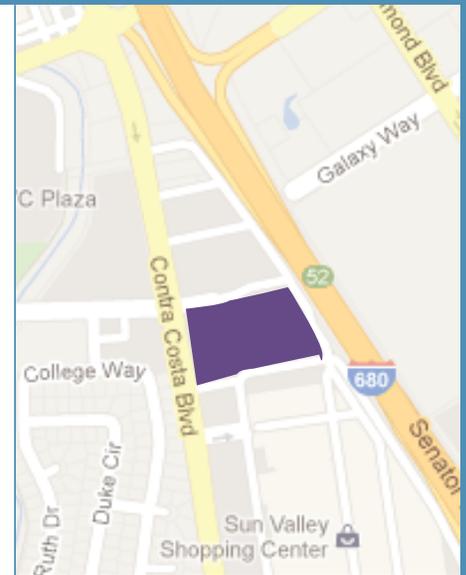
Retail Area Location

Paint: Uninteresting white, in good condition.

Storefronts: Glass/aluminum.

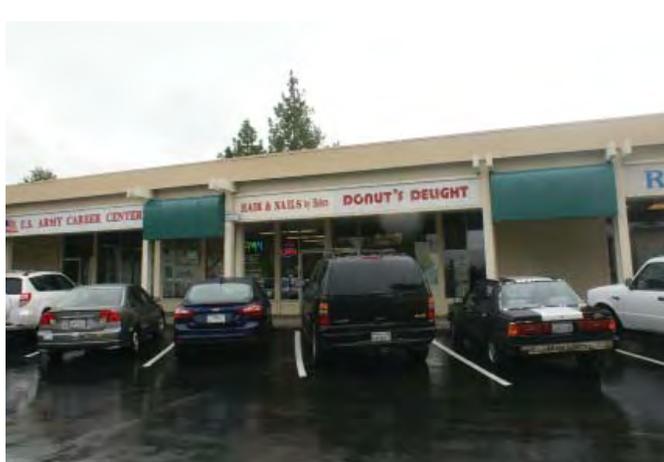
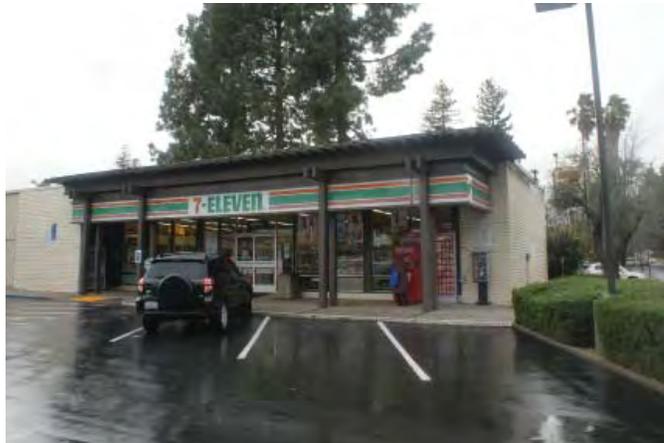
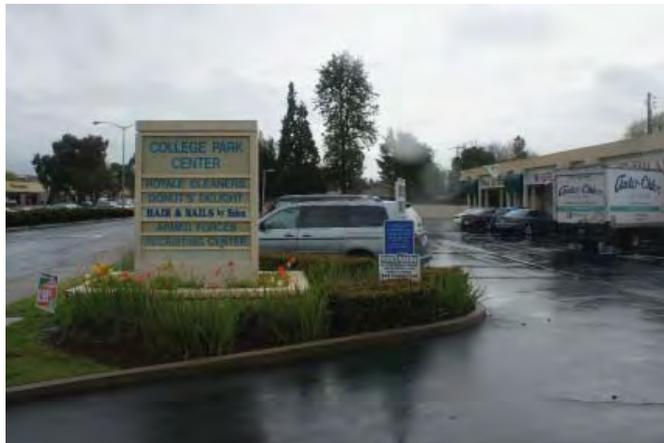
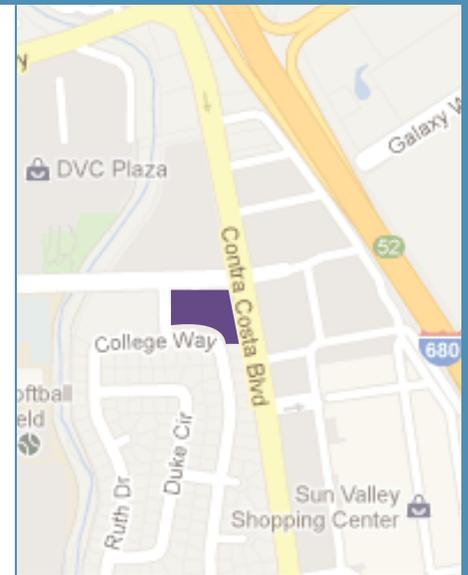
Retail Area Location

Building Facades: In decent repair- boring color scheme, awkward green mini awnings. Aluminum storefronts.

Paint: Boring but in decent condition.

Storefronts: Lacking individuality but overall in good repair.

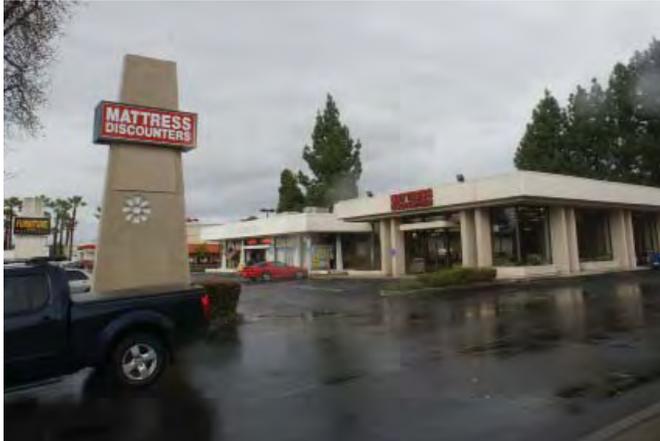
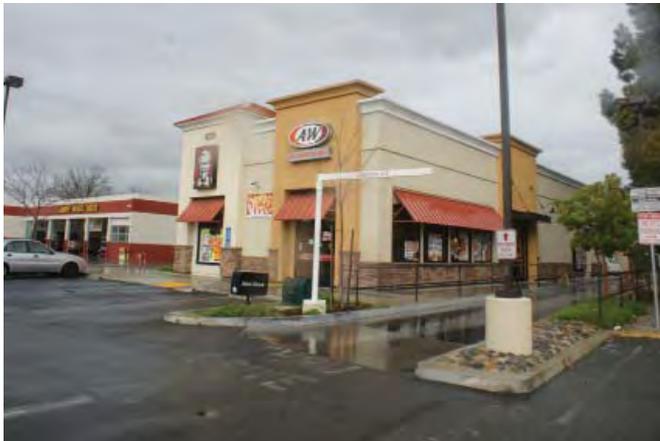
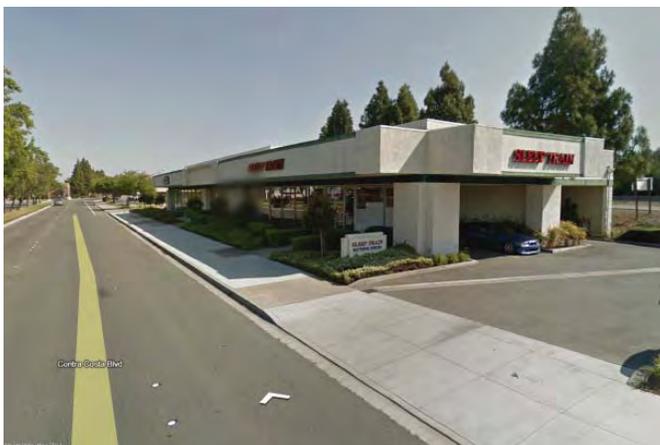
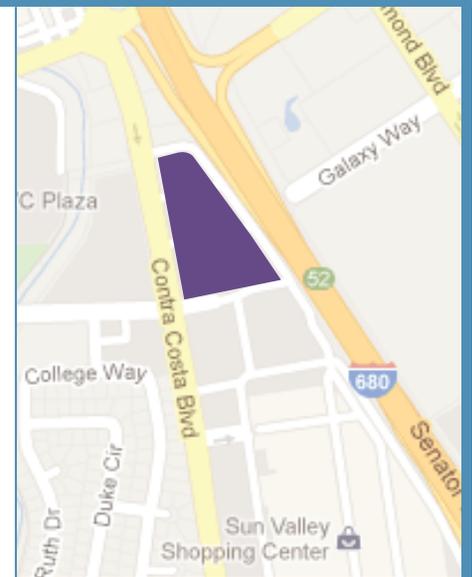
Retail Area Location

Paint: Mostly decent condition- again, mattress store needs a lot of work.

Storefronts: Sleep train is good, Casual Male XL is good, though predictable—Mattress store needs a lot of work. However, it has a decent amount of existing glazing and could be wonderful if given attention.

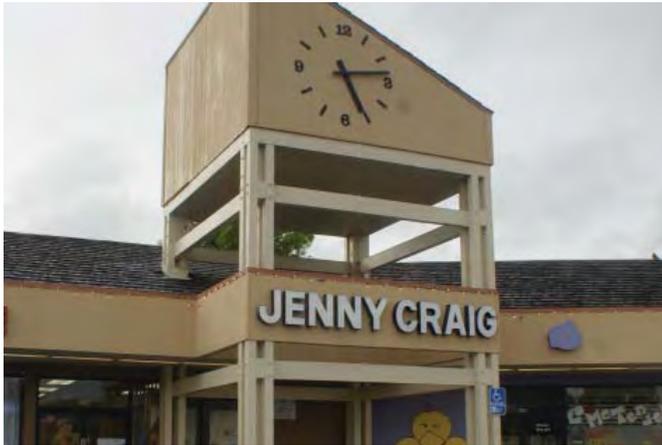
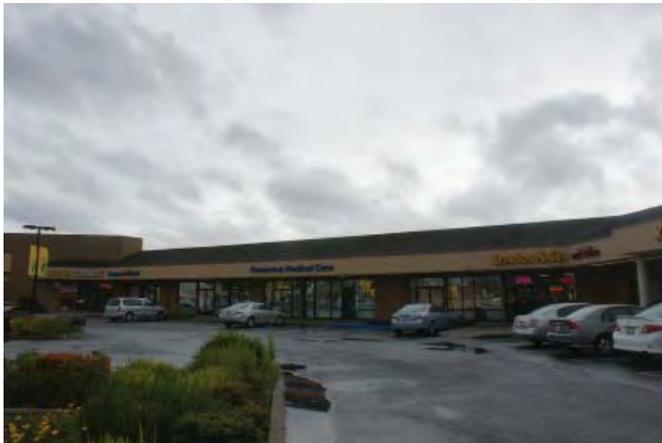
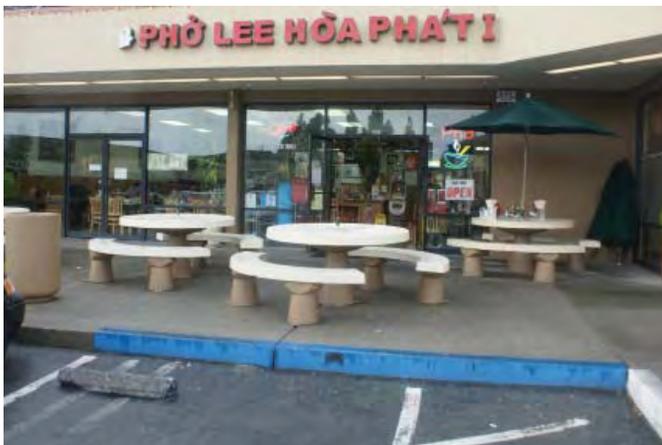
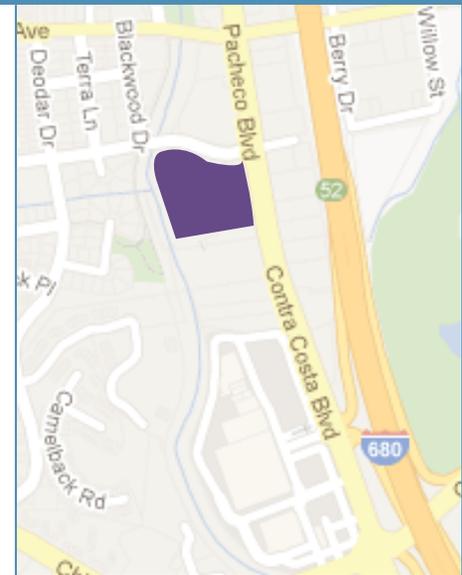
Retail Area Location

Patios: Some outdoor seating, a little worn and rather generic.

Site Signage: Giant freestanding monument sign—looks a bit like a treehouse. Tenant signage on it in interior lit box signs which need repair or replacing.

Building Facades: Decent condition, mid century architecture in a variety of tans and browns.

Paint: Good condition—Tan and brown. Boring and predictable, no sense of place.

Storefronts: Lots of glass uniform, metal trim, little to no storefront variation.

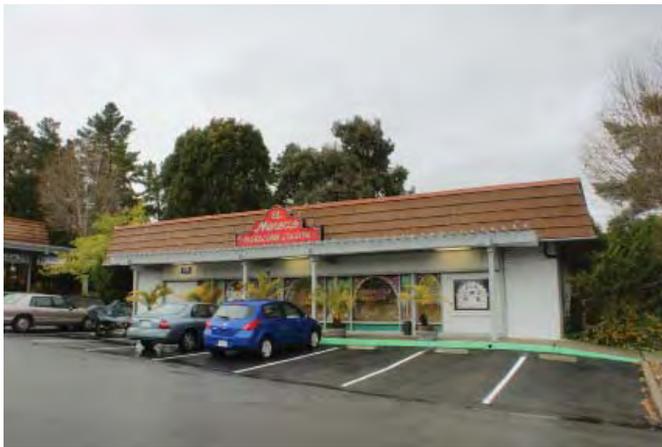
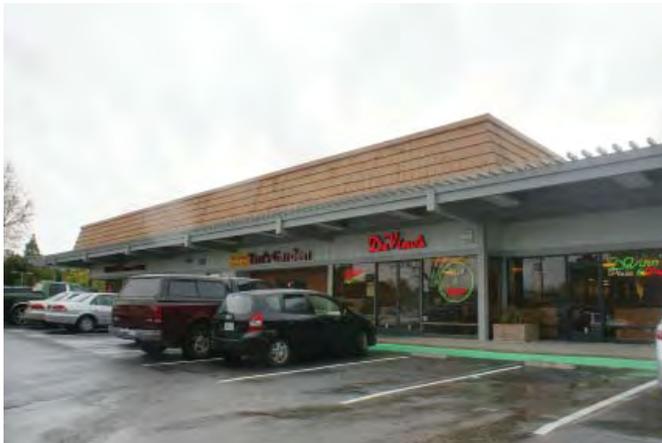
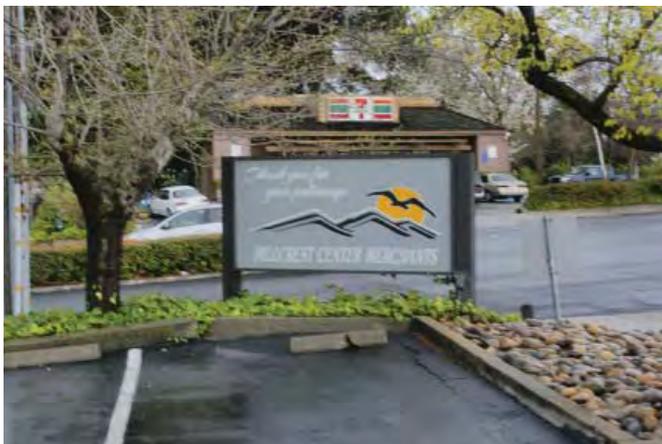
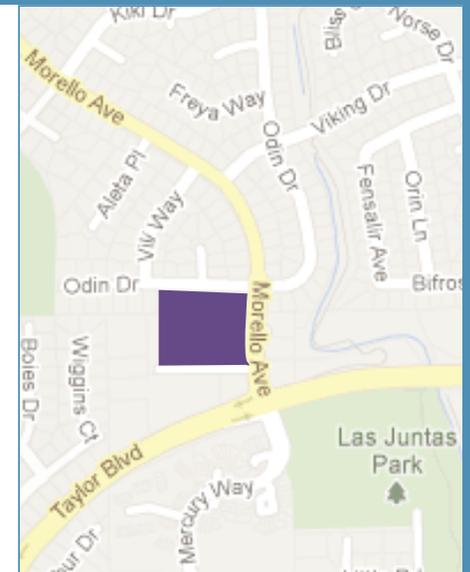
Retail Area Location

Site Signage: 2 monument signs and 1 directory sign. All could use an updated image. A single additional wall/edge sign on roof which is in better repair and slightly more designed.

Tenant Signage: Most tenant signs are too large. Internally lit push through acrylic, some in need of repair.

Paint: Boring uniform grey, in decent condition.

Storefronts: Glass & Wood frames with some aluminum. Boring and uniform.

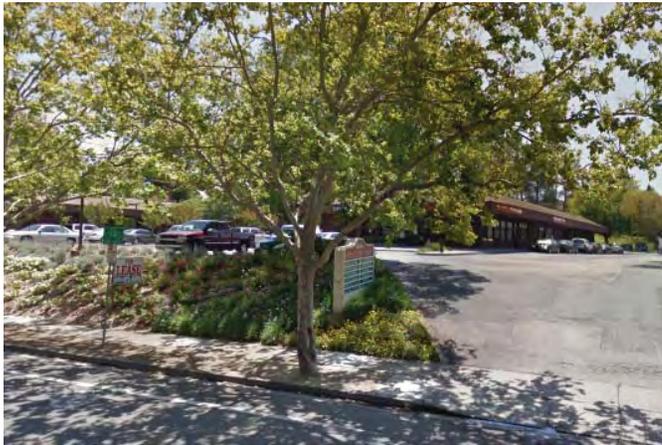
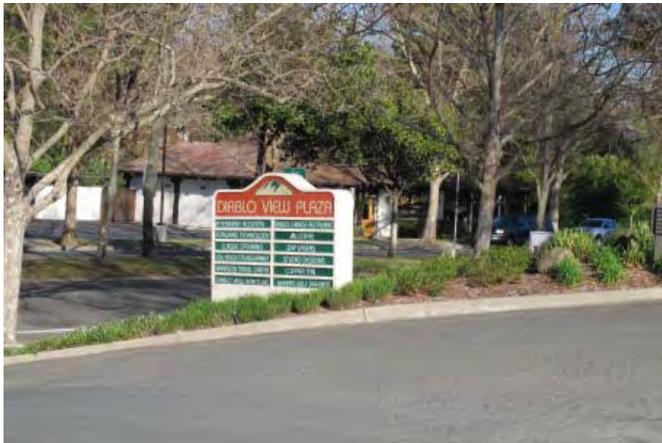
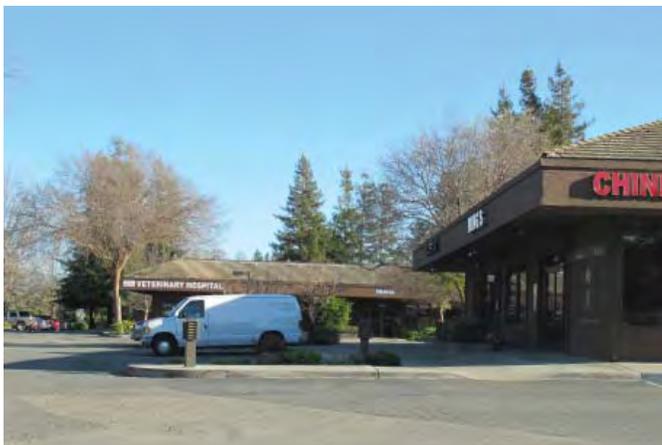
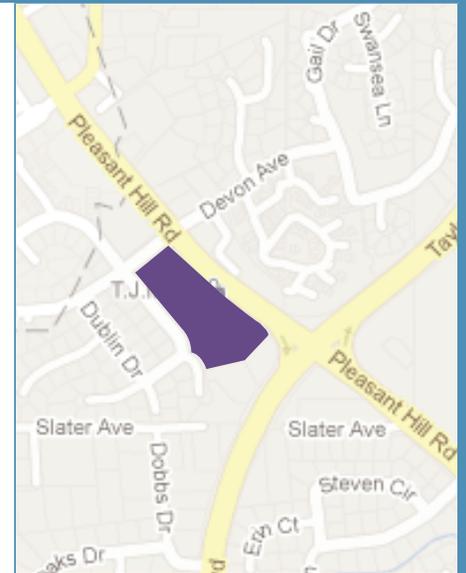
Retail Area Location

Site Signage: Uninteresting and in bad repair.

Building Facades: In good condition, standard strip mall assortment.

Paint: In good repair but nondescript.

Storefronts: Good.
