SURVEY & DOCUMENTATION

Our Pleasant Hill Commercial Study focused on three main areas of the City: Retail Centers, Streetscape Conditions, and Gateway Monuments.

Retail Assessment Introduction

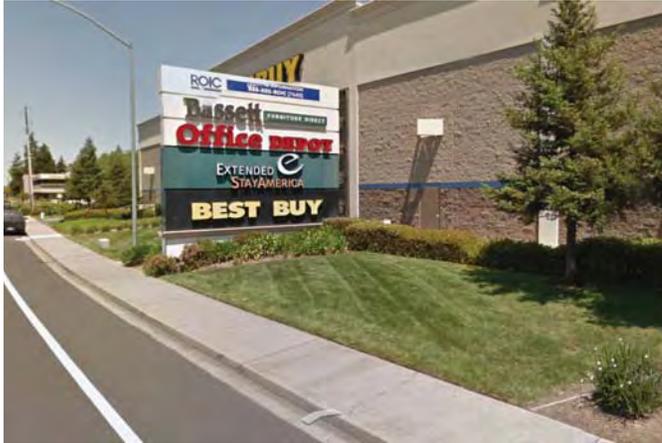
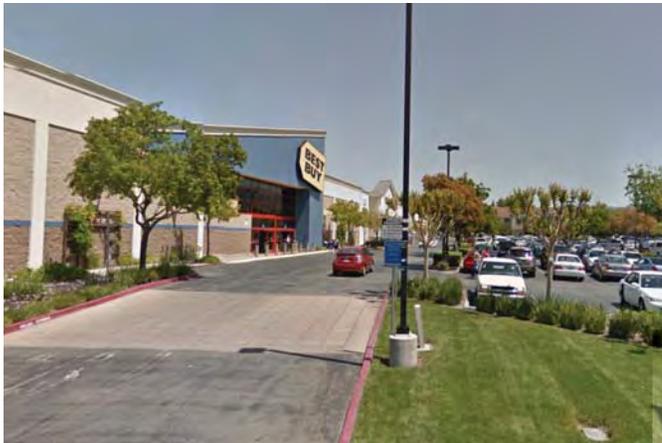
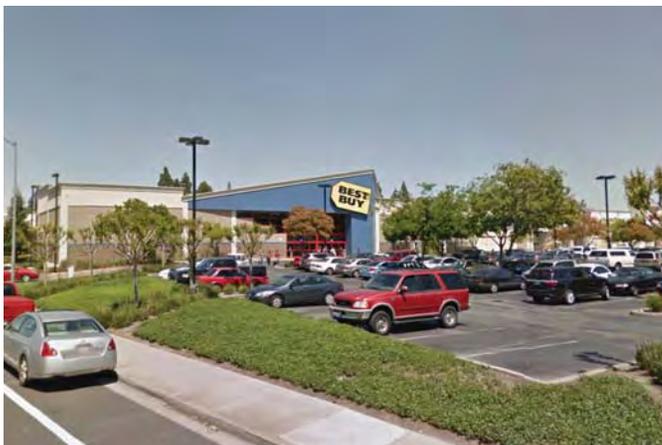
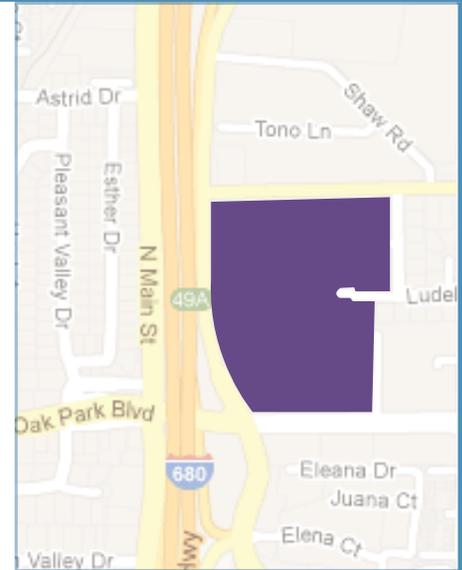
Best Buy

Edges/ Boundaries: Very well landscaped and defined.

Paint: Very Good.

Storefronts: Good.

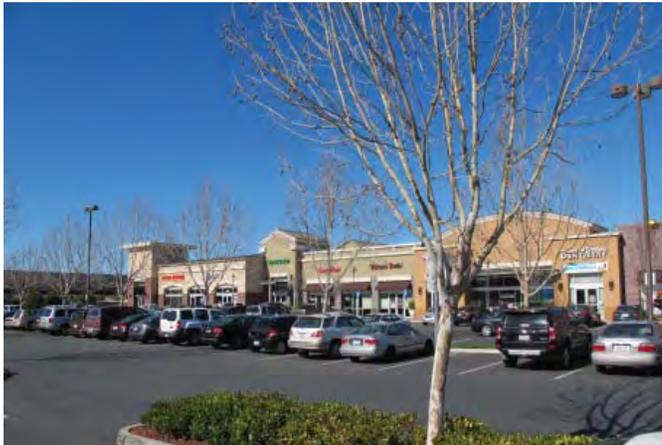
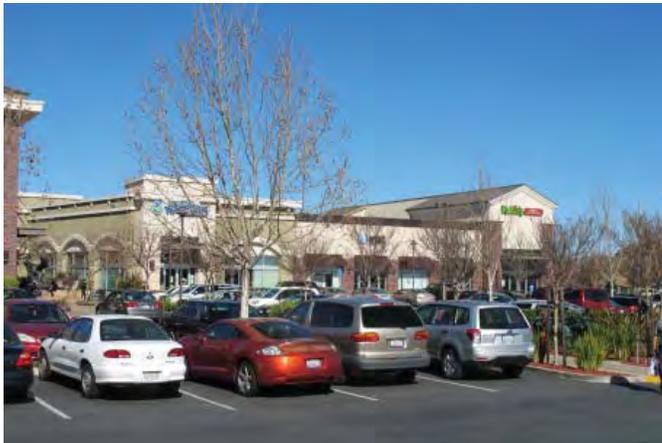
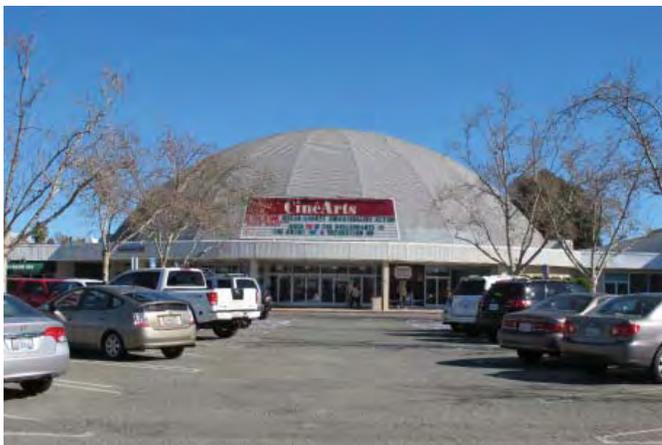
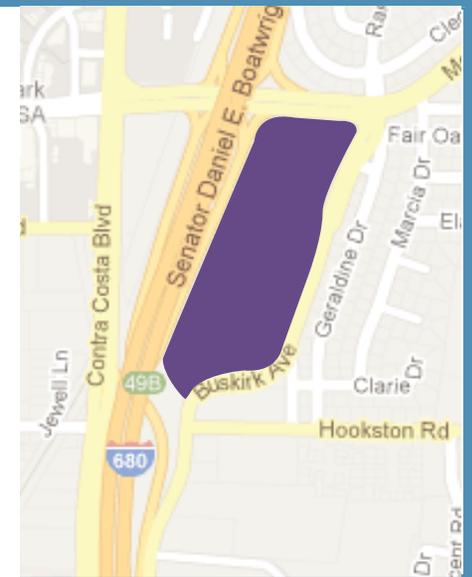
Crossroads (Cine Arts, Marshalls)

Paint: Very good.

Storefronts: Good.

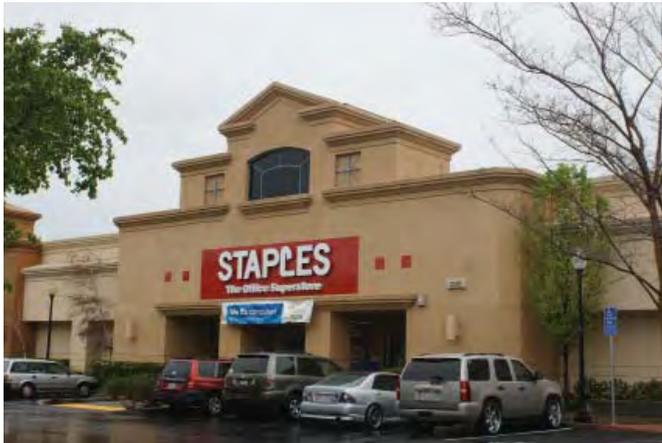
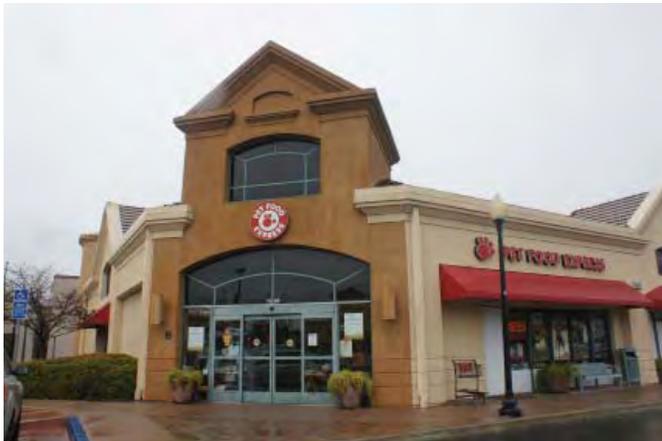
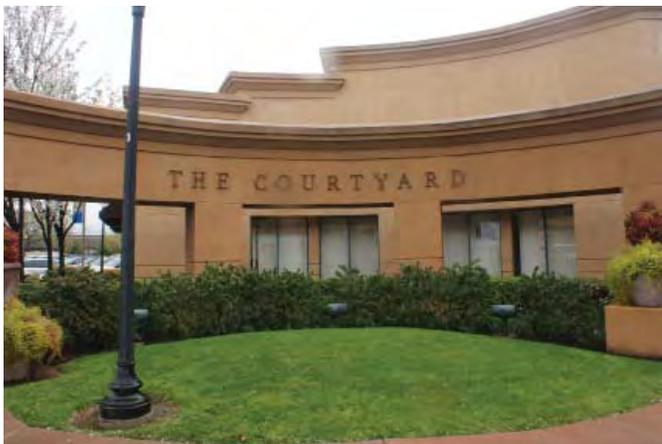
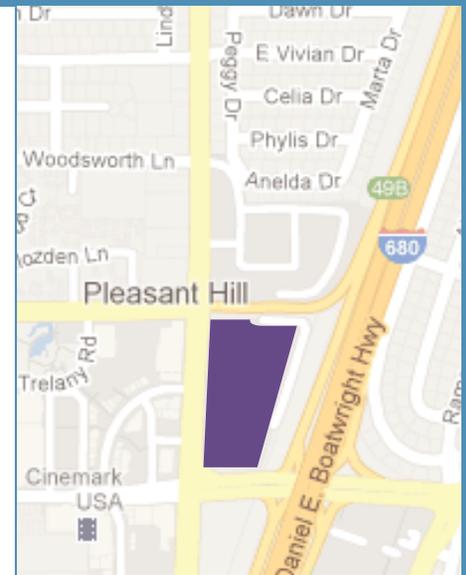
Courtyard

Paint: Newly painted, but a bit boring.

Storefronts: Little variation between storefronts, not enough windows or individuality.

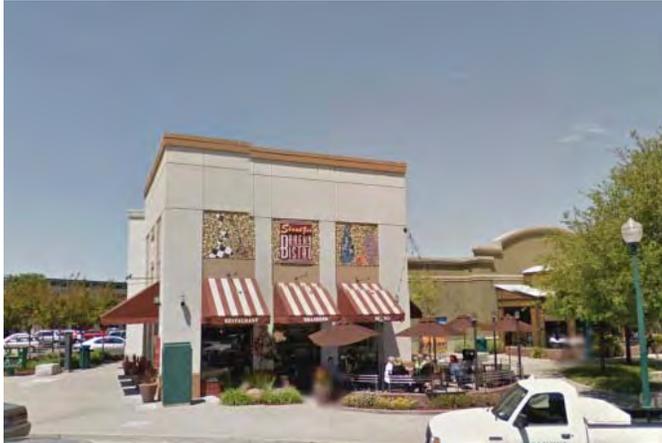
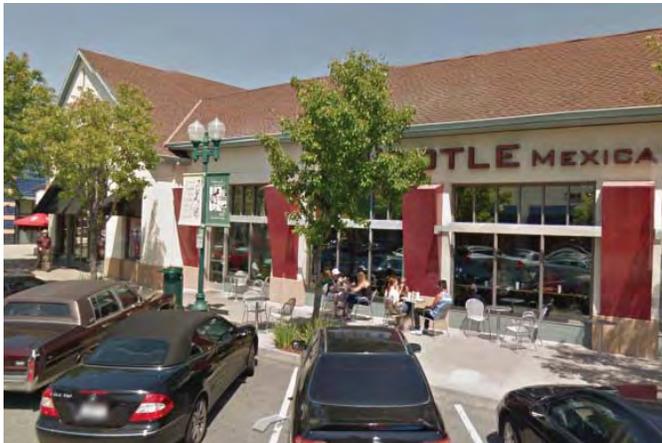
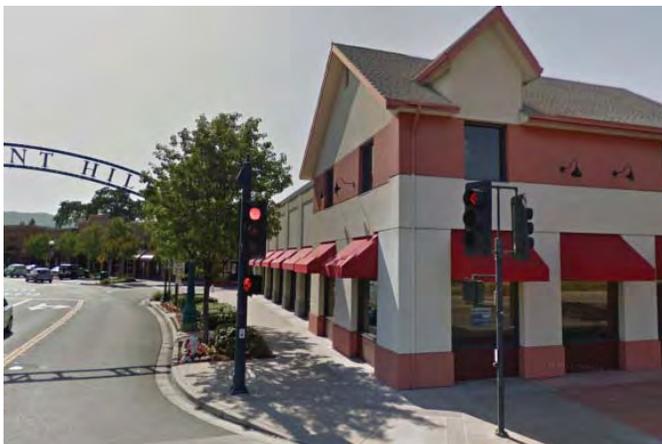
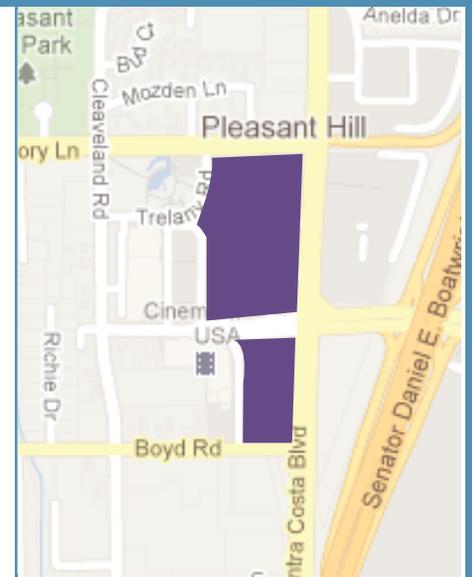
Downtown

Building Facades: Varied but mostly in wonderful condition.

Paint: Good.

Storefronts: An appealing variety.

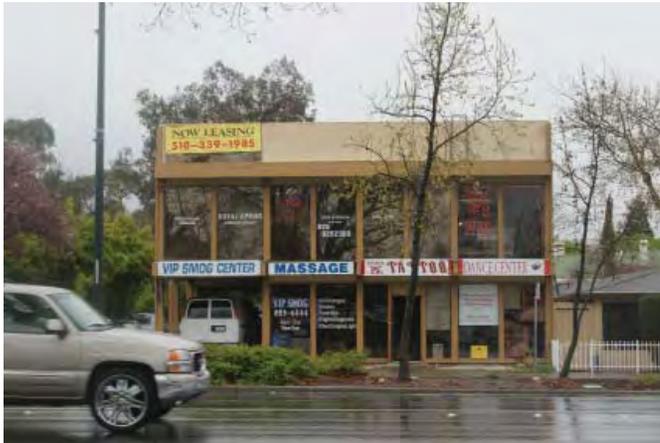
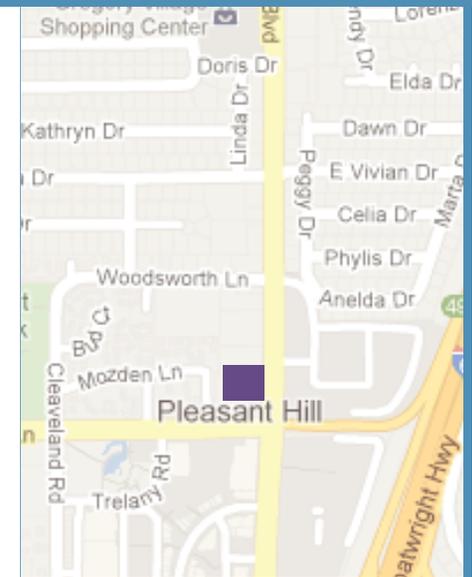
Smog / Massage Building

Paint: Varying shades of brown/tan.

Storefronts: Lots of glass, only one door.

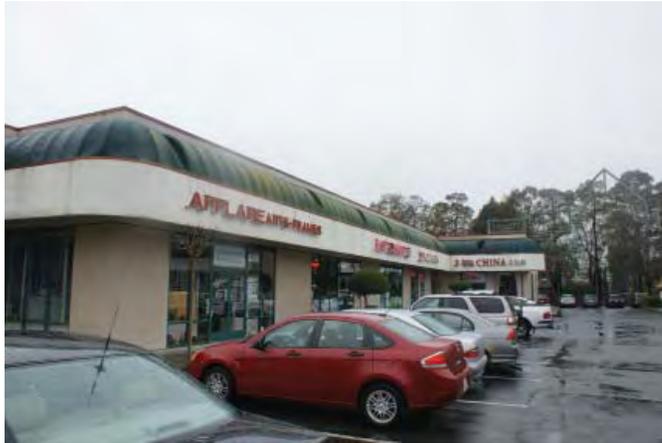
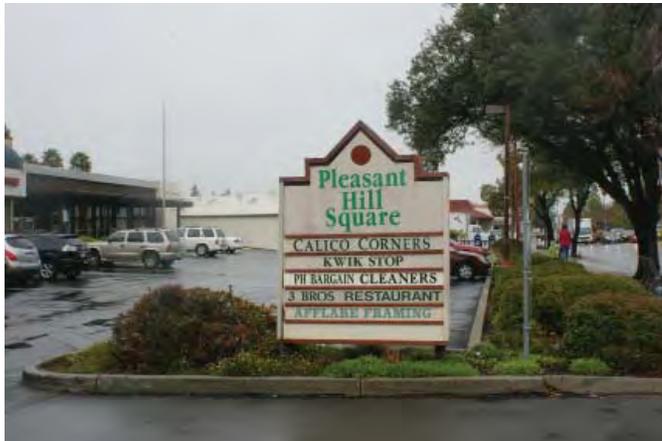
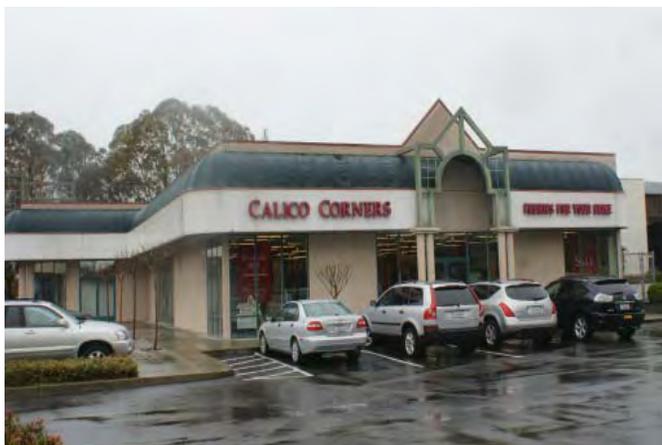
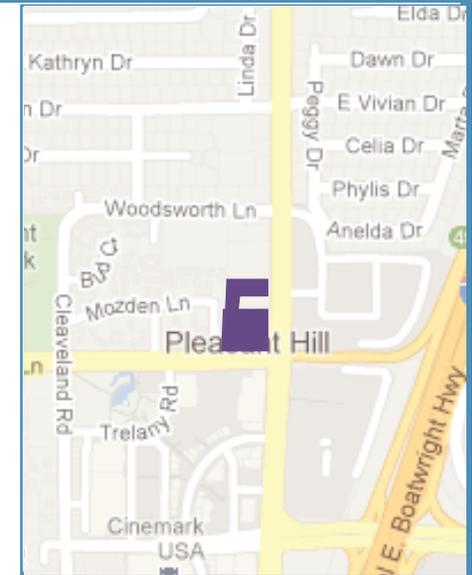
Monument sign at entry (lacking design flair and in need of cleaning/repair) large decorative frame spanning buildings.

Aluminum frames painted green to match awnings, glass and stucco. Blocked glazing throughout.

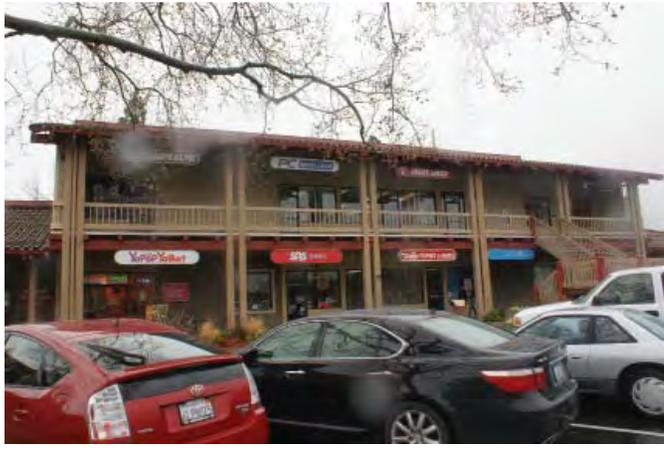
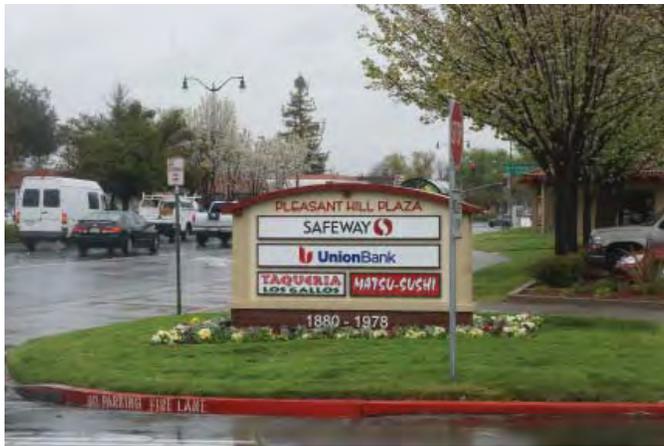
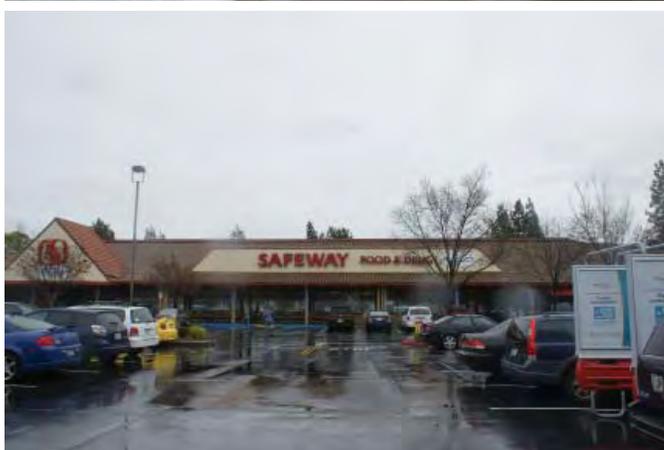
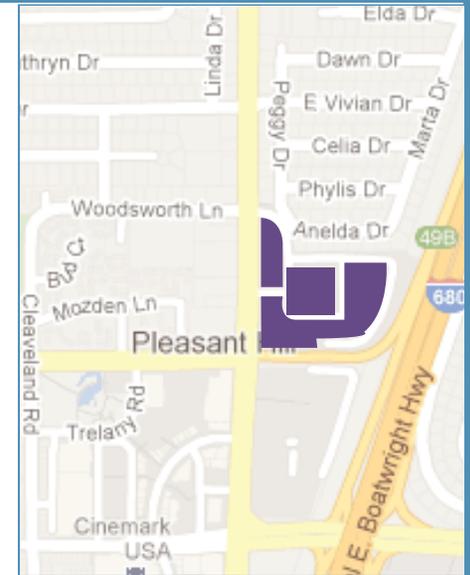
Pleasant Hill Plaza

Mostly recessed storefronts under overhang.

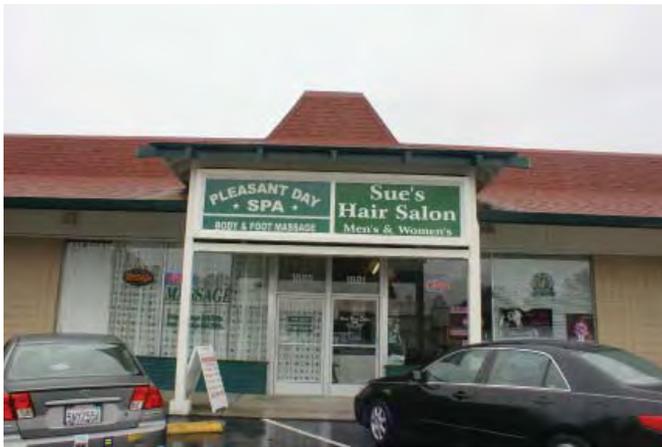
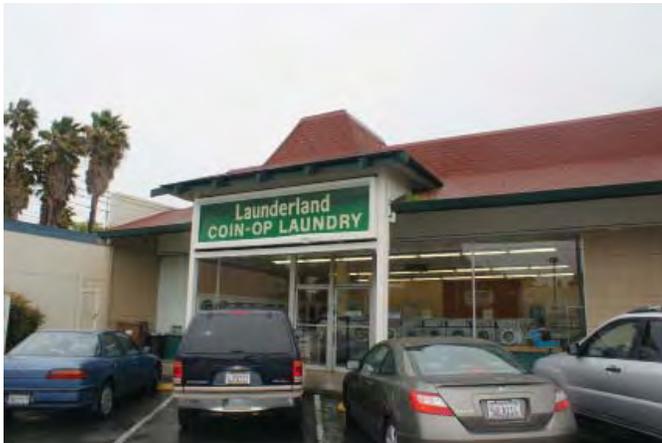
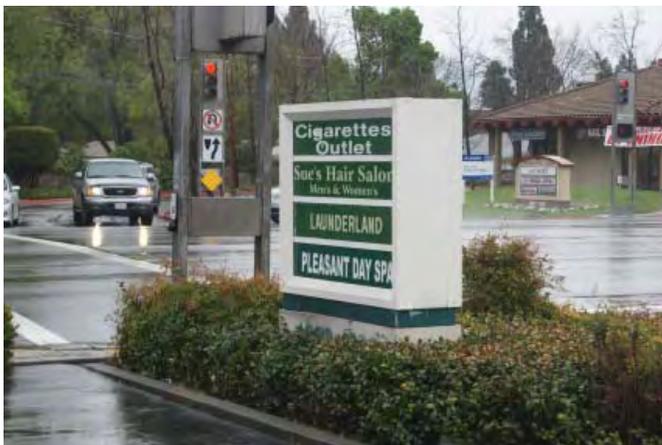
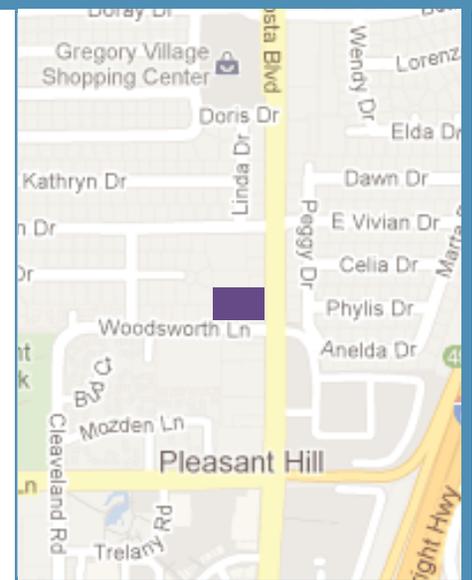
Woodsworth Plaza

Trash Enclosures: In front, in need of paint/repair.

Building Facades: Brick with tile and overhang. In fine repair but unattractive.

Paint: Good.

Storefronts: Standard aluminum framing and glass.

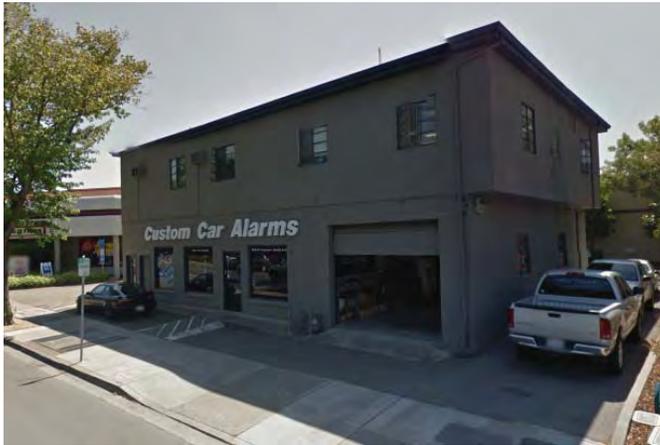
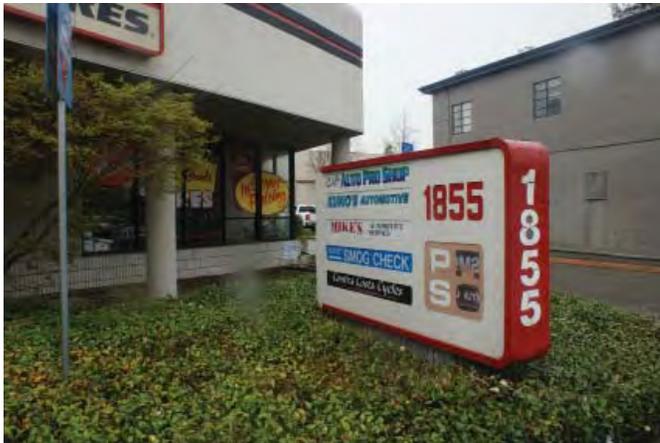
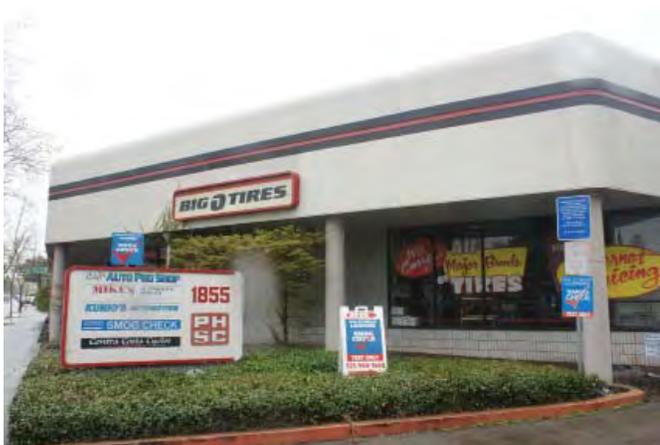
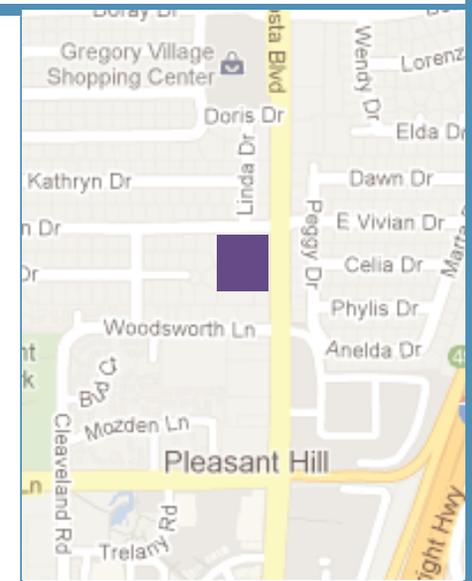
Auto Businesses

Building Facades: Varied, but mostly well maintained and in good repair.

Paint: Varied from building to building. White and tan mostly.

Storefronts: Strangely non-existent with minimal visibility.

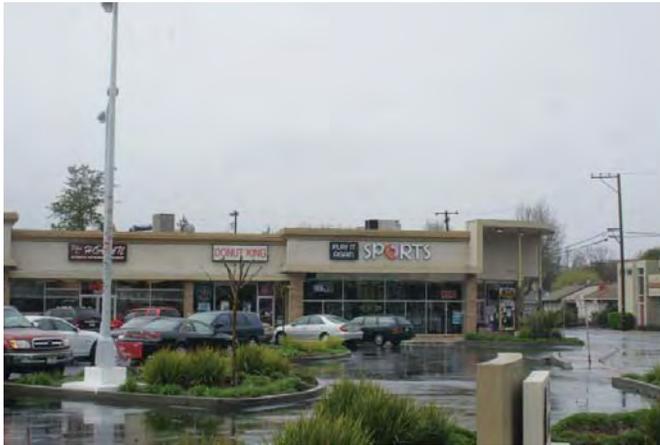
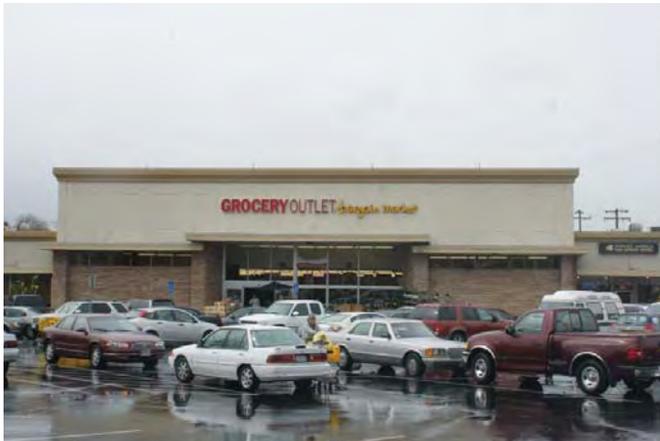
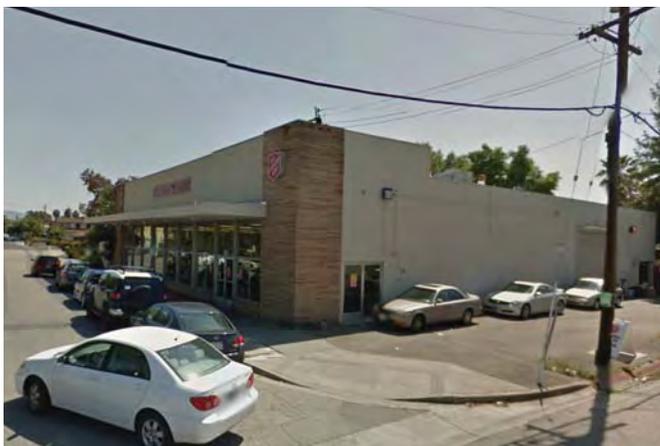
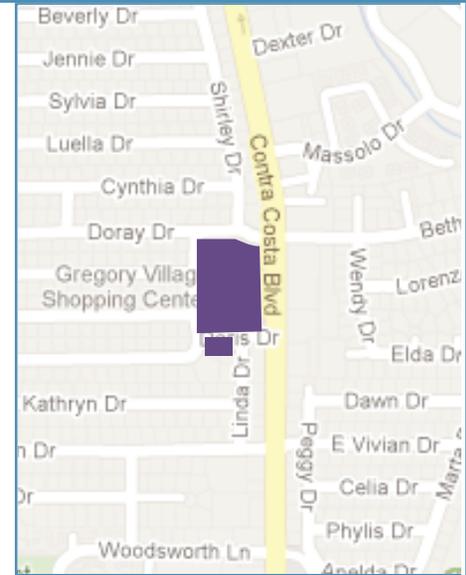
Paint: Poor and in need of accent colors.

Storefronts: Standard aluminum framing and glass.

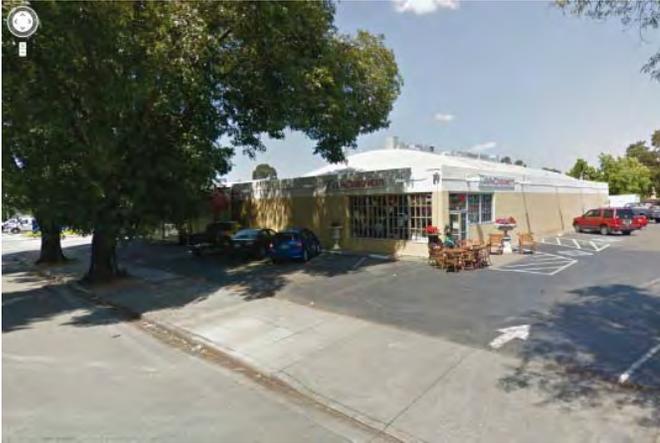
Building Facades: In good repair.

Paint: White and tan and in good reappear.

Storefronts: Too few windows on street- building seems forboding.

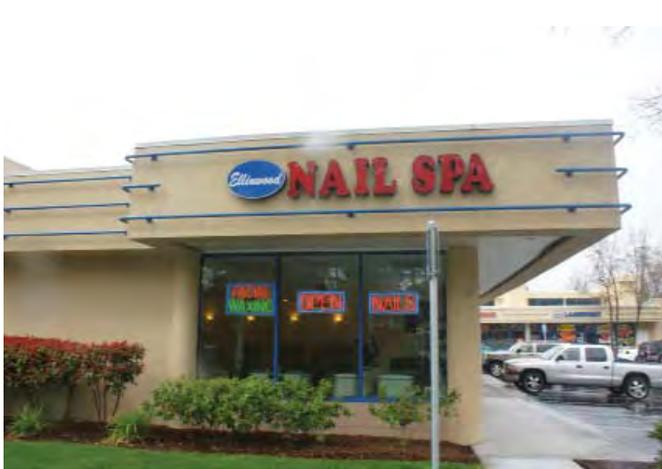
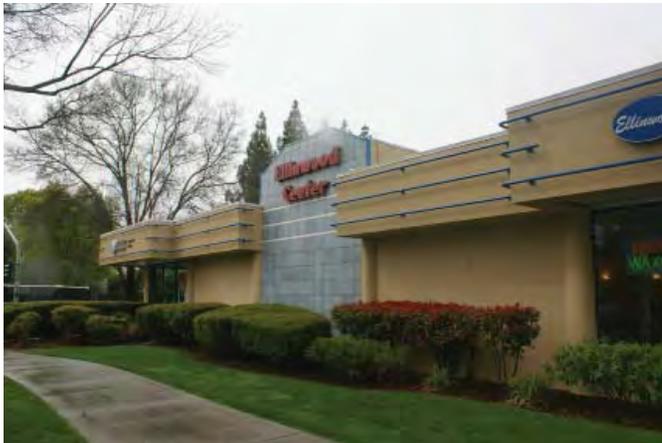
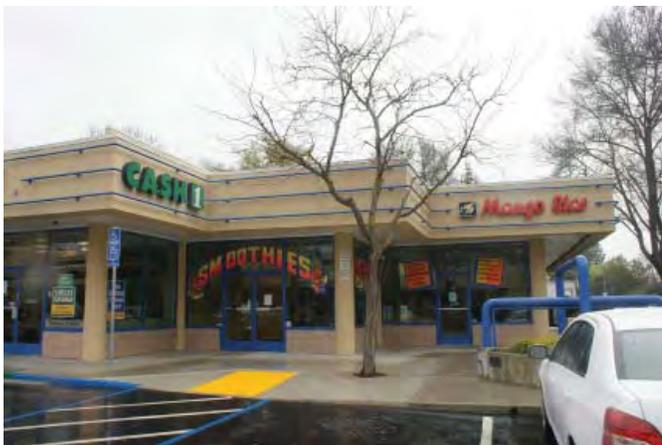
Paint: In good repair—tan with a bright blue accent color.

Storefronts: Glossy aluminum frames painted blue—no variation of color or approach between spaces.

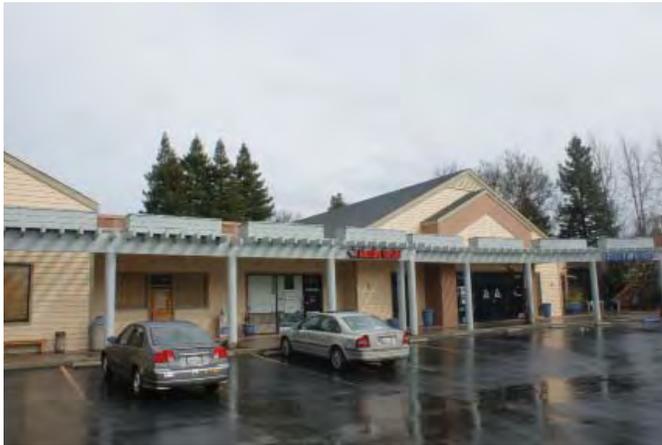
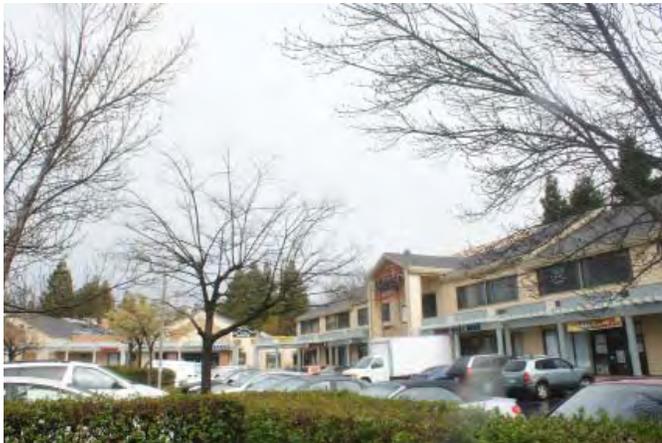
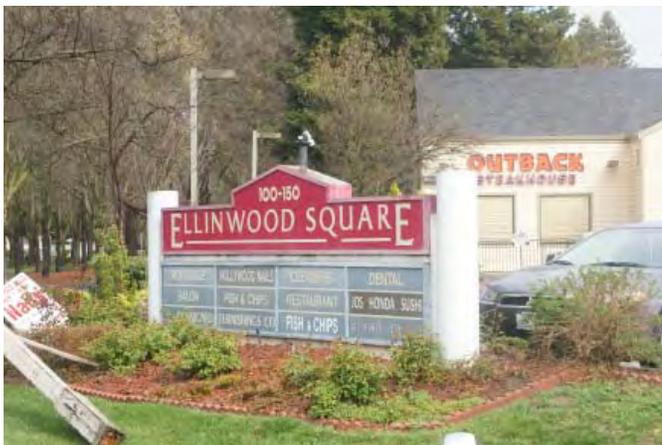
Ellinwood Square (Ellinwood 3)

Landscaping: Grass, some trees / shrubs etc. needing repair / basic upkeep in some areas.

Site Signage: Monument sign- Unattractive and in need of repair. Large wall sign on one building.

Tenant Signage: Most tenant signage mounted on rotting trellis bordering sidewalk, with many signs drastically in need of repair and updating. Outback Steakhouse only has one permanent sign, which is awkwardly placed off to the side of entrance.

Building Facades: In need of repair and maintenance

Paint: Peeling in places, (mostly on trellis).

Storefronts: Glass doors with smaller windows and very little differentiation or individuality.

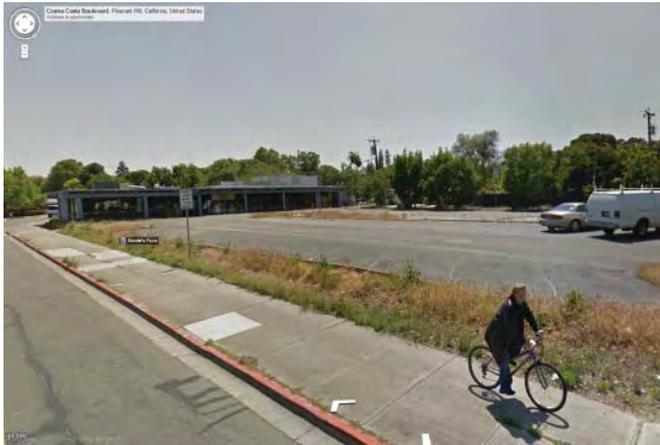
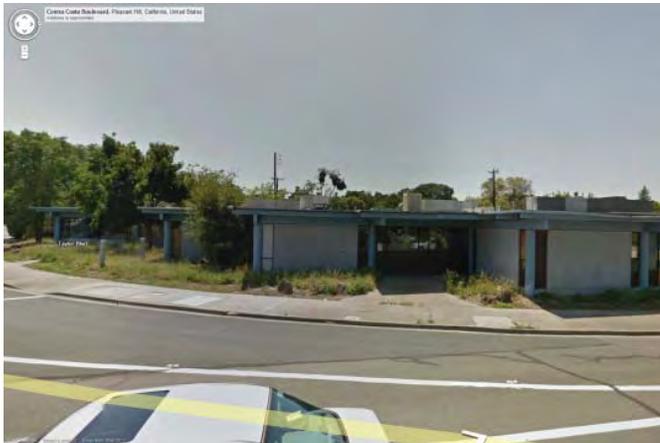
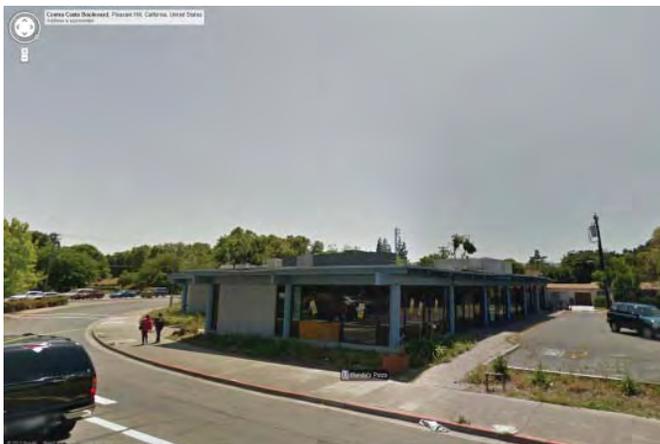
Blondie's Pizza / Rasputins

Building Facades: Battered and in bad condition.

Paint: Needs painting badly.

Storefronts: Has the potential for very inviting storefronts.

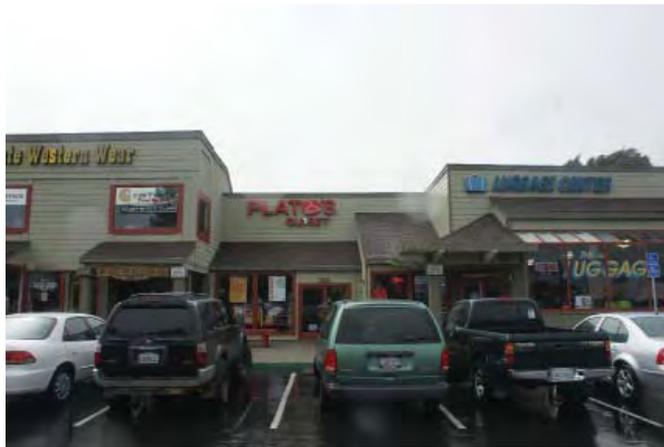
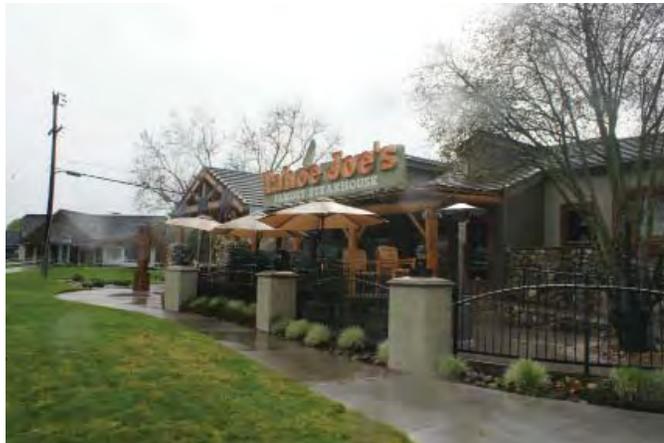
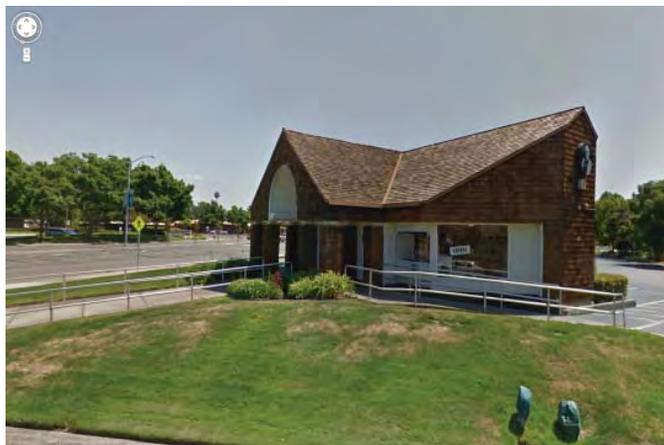
Tahoe Joe's

Paint: In good repair, nice accent colors.

Storefronts: Recessed entries are a little dark, otherwise things are good.

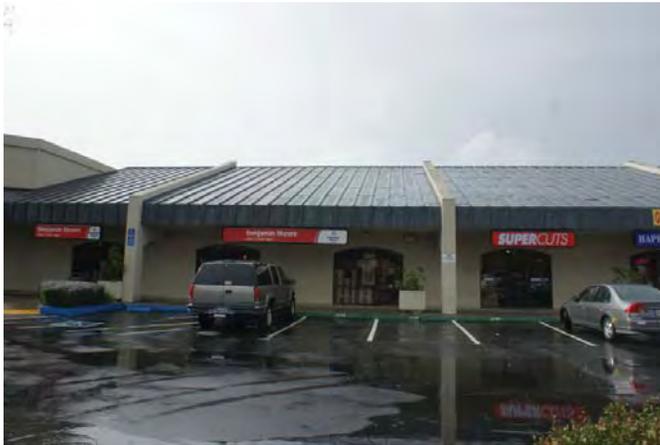
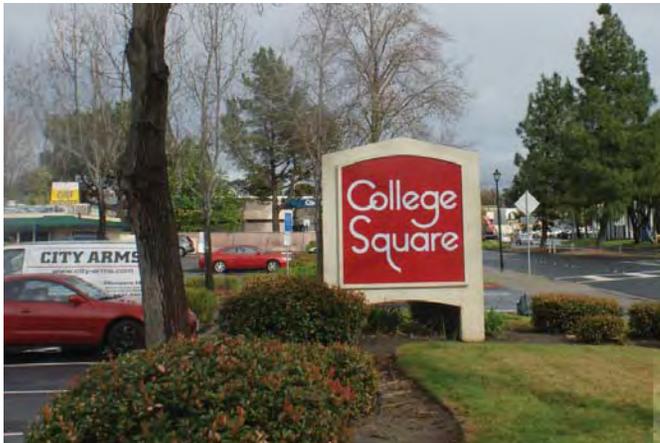
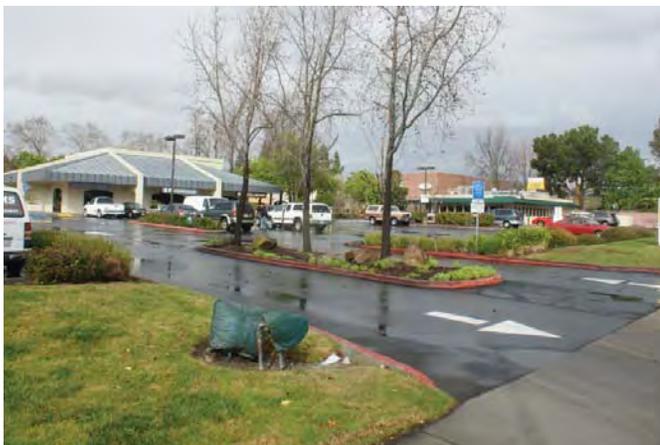
Building Facades: Cream stucco, in good repair.

Paint: Maintained but uninteresting.

Storefronts: Single glass / aluminum storefront opening per space. Not enough glazing.

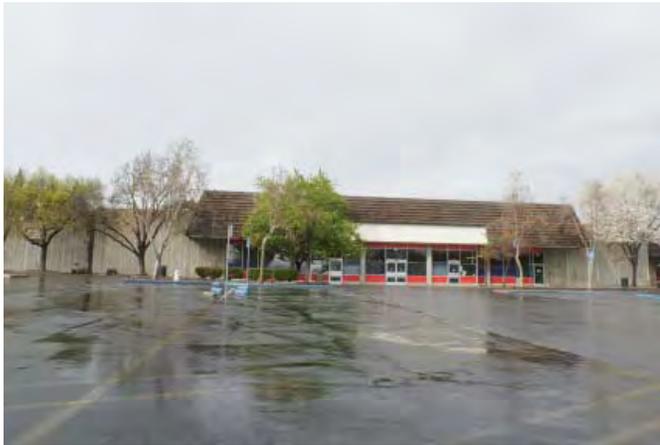
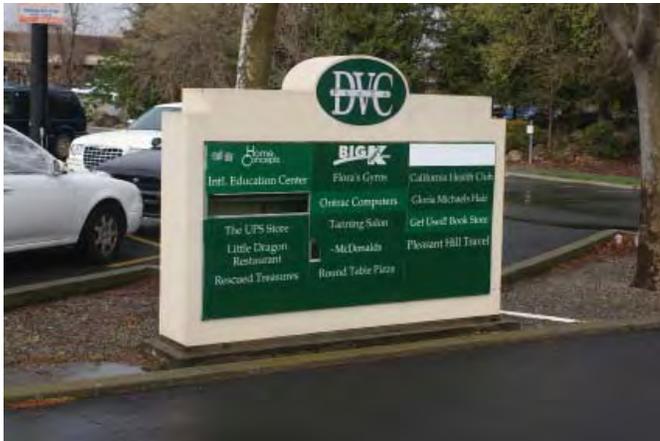
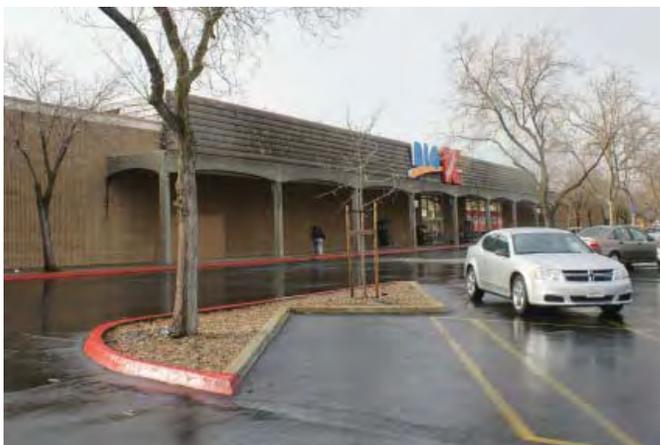
DVC Plaza

Building Facades: Generally in bad repair- very worn and dated looking.

Paint: Peeling and in disrepair in places.

Storefronts:Very few functioning storefronts- mostly large windowless walls and empty spaces.

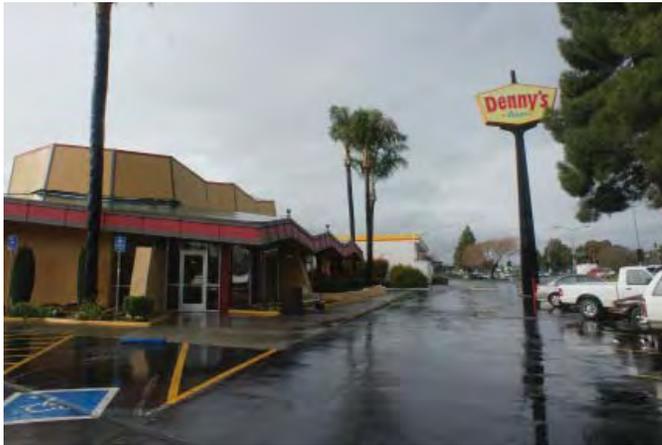
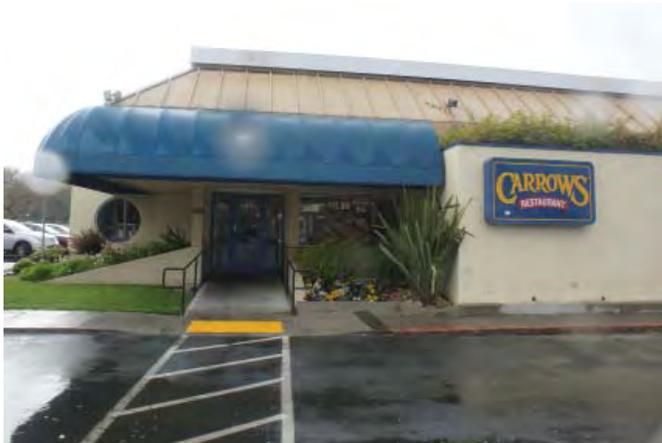
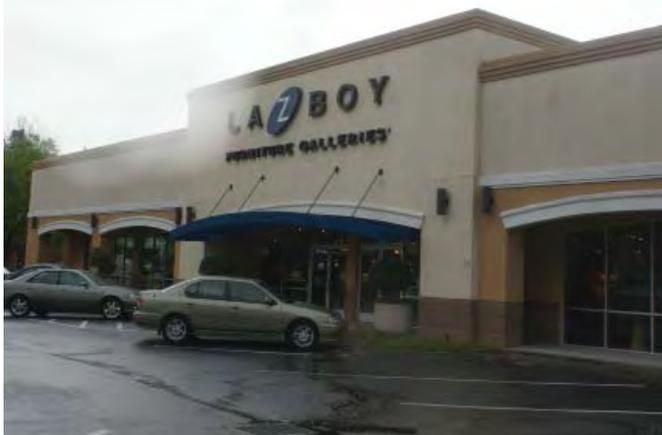
Upper Contra Costa, West

Site Signage: Varied monument signs in varying states of design and repair.

Paint: Mostly decent condition—again, Denny’s and Carrows need work.

Storefronts: LAZ Boy is the only real storefront, and utilizes extensive glazing and a well thought out color palate.

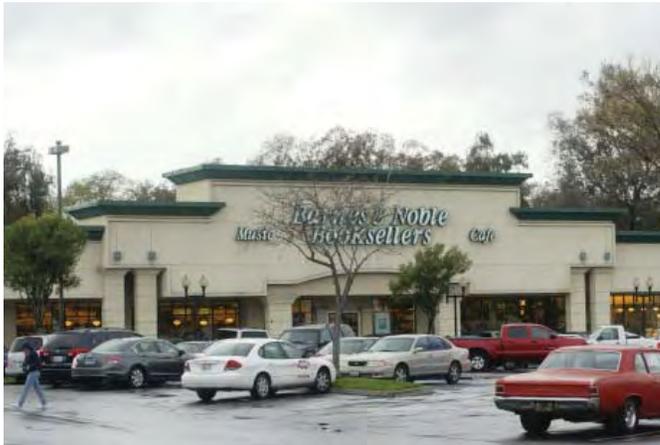
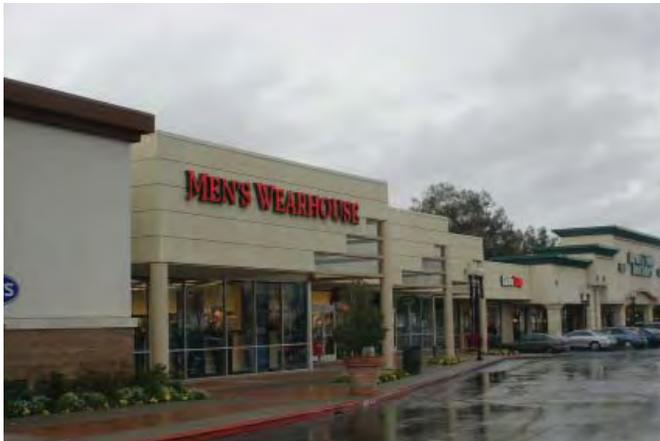
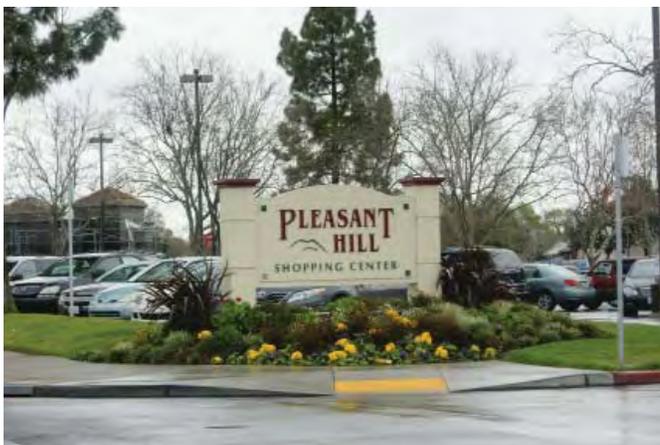
Building Facades: Good condition, nice change of color, style and materials from space to space.

Paint: Good condition, neutral tones with accent colors for the most part.

Storefronts: Welcoming, well lit, enjoyable differentiation between spaces.

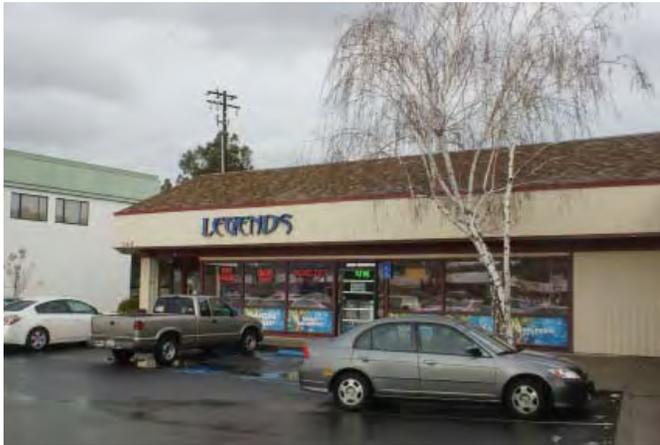
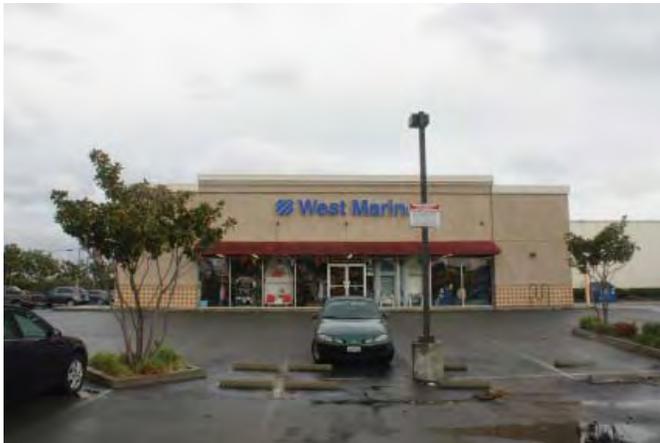
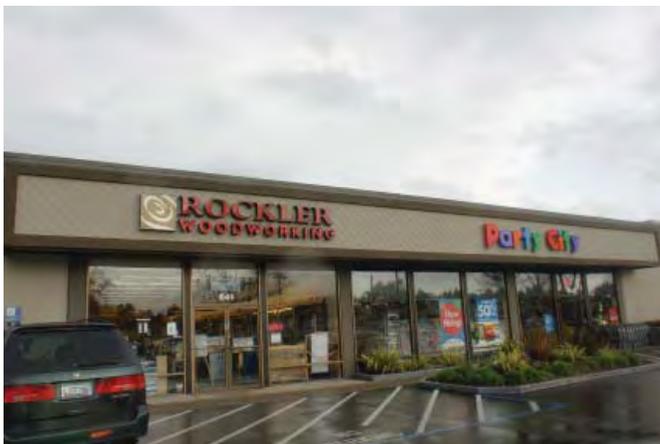
Legends

Site Signage: Good at street, sparse elsewhere. This area is mostly comprised of individual building pads, and the lack of unification in any sort of site signage reflects this. There are 3 or 4 small monument signs with tenant logos on them bordering the street, all in various states of upkeep and repair.

Building Facades:Varied states of repair and design.

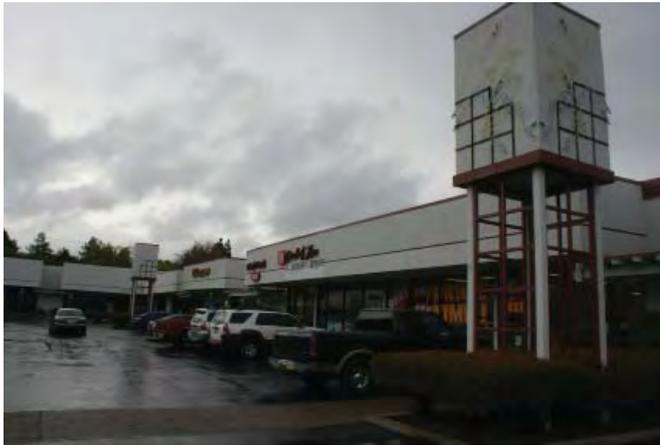
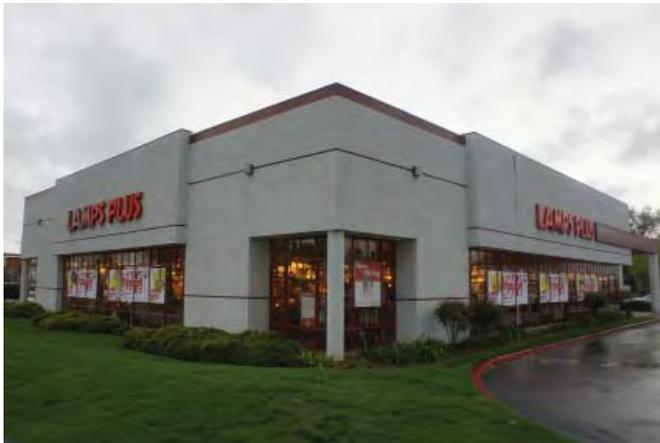
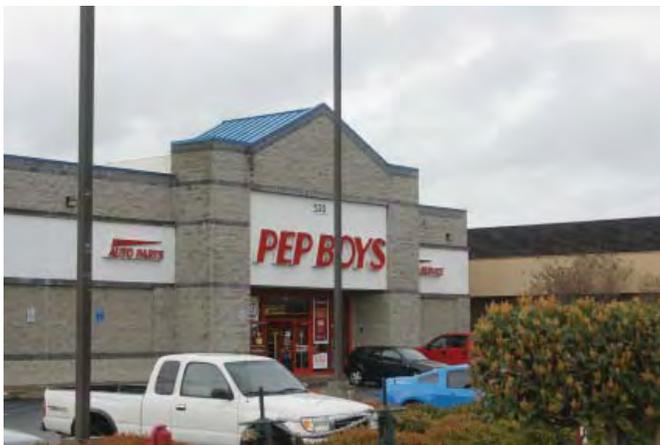
Building Facades: Decent condition, mid century architecture with inset red accent colors—outdated but in well kept condition.

Paint: Good condition—white with red accent colors. Boring and predictable, no sense of place.

Storefronts: Lots of glass but too much glazing blockage. Uniform metal trim, etc.

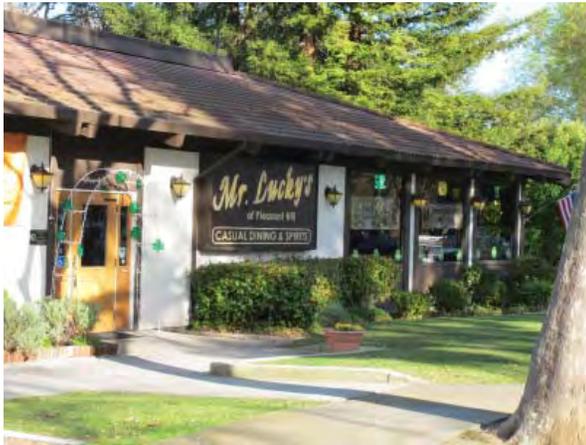
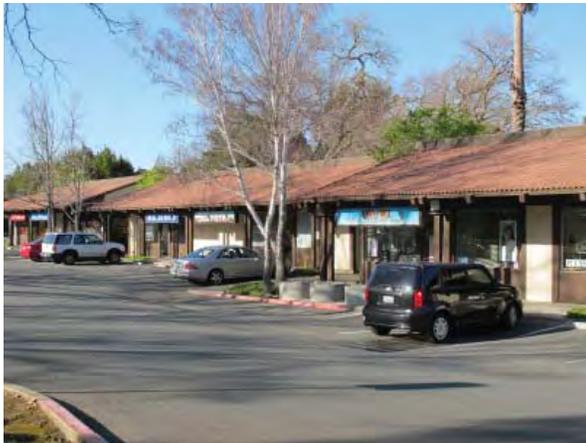
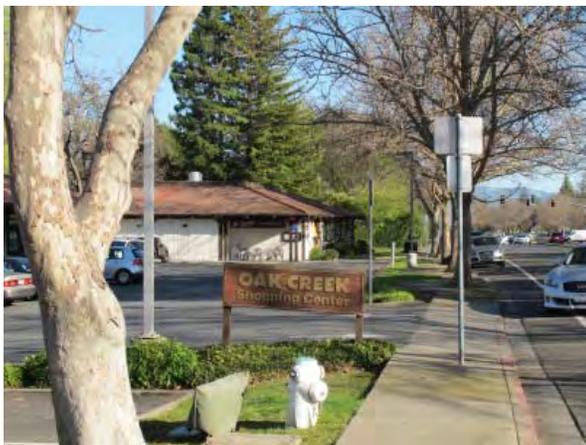
Paint: In good repair but uninteresting.

Storefronts: Contain a decent amount of glazing but are also nondescript.

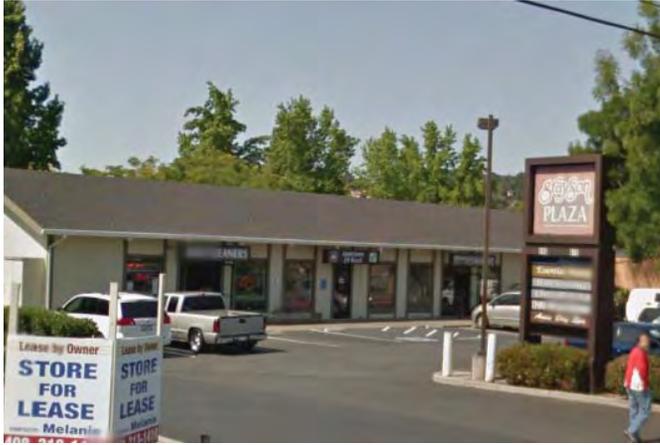
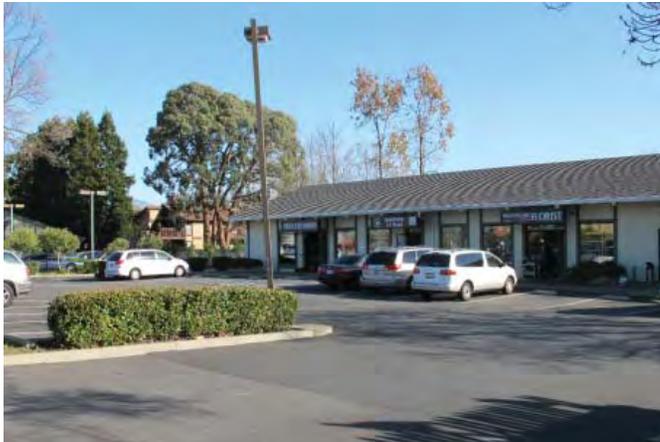
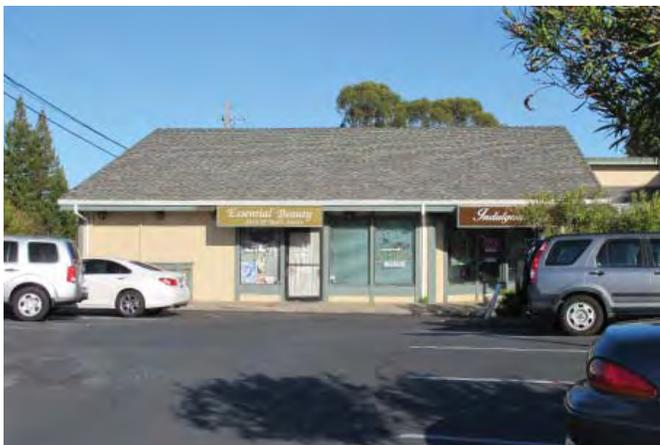
Building Facades: A bit traditional, but in good condition and repair.

Paint: White with gray trim—in good repair.

Storefronts: Relatively small windows and doors but in good condition.
