SURVEY & DOCUMENTATION

Our Pleasant Hill Commercial Study focused on three main areas of the City: Retail Centers, Streetscape Conditions, and Gateway Monuments.

Retail Assessment Introduction

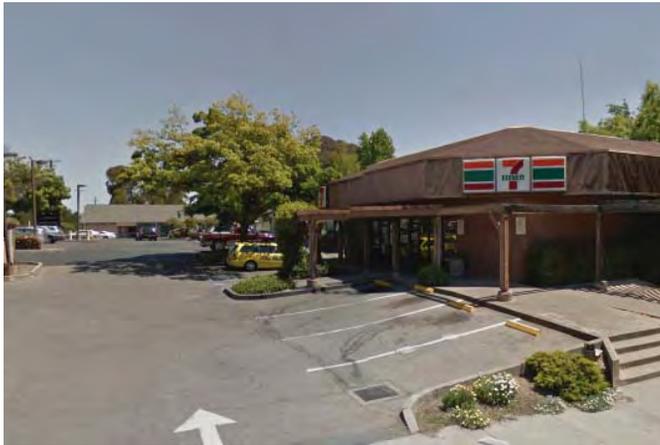
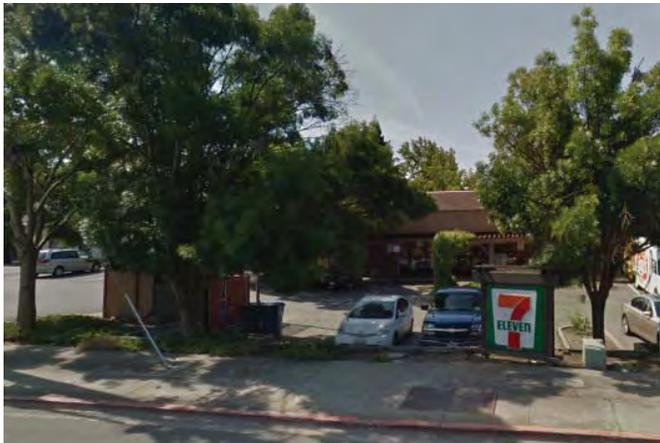
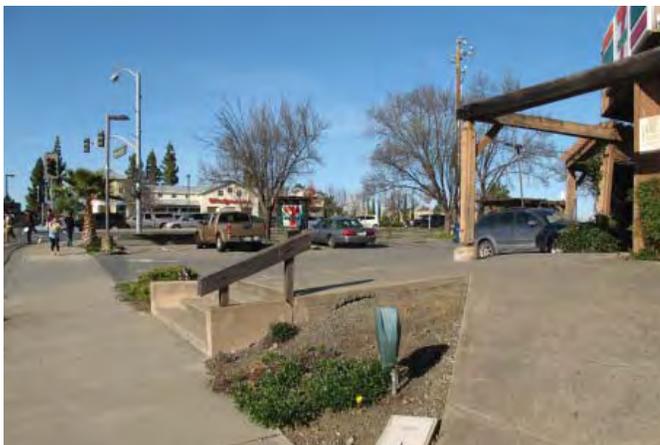
Paint: Shades of brown, peeling in places.

Storefronts: Recessed and dark entrance.

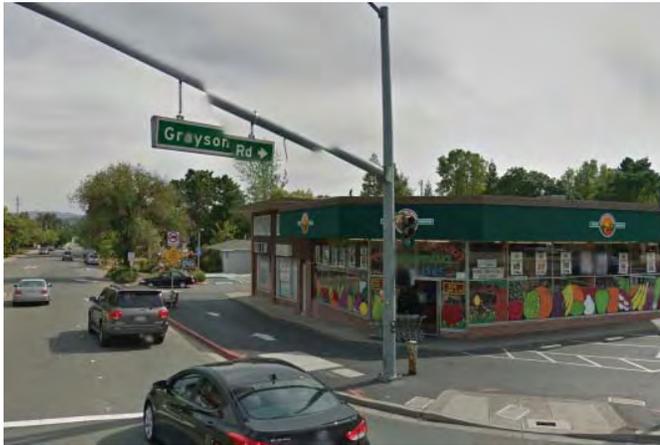
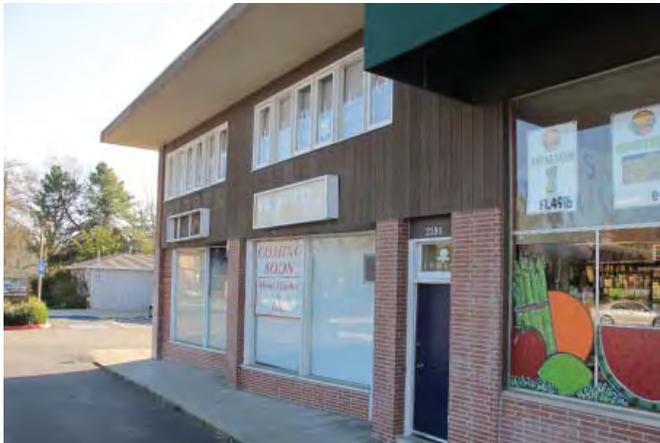
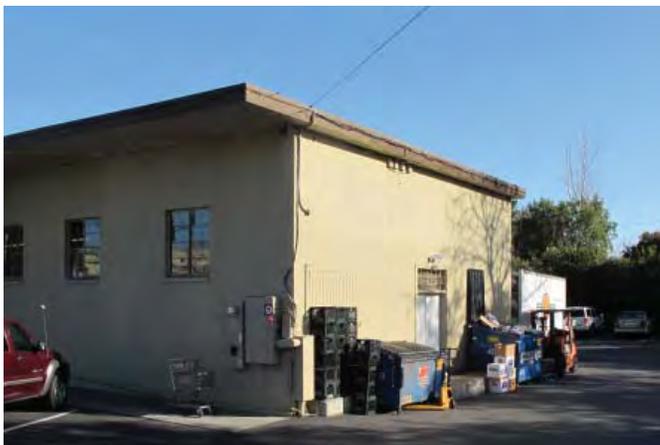
- Tenant Signage: Nice overhang signage in three places.
- Building Facades: Lots of glass and a well utilized overhang.
- Paint: Fine.
- Storefronts: Nice use of window graphics, but far too much window blockage.

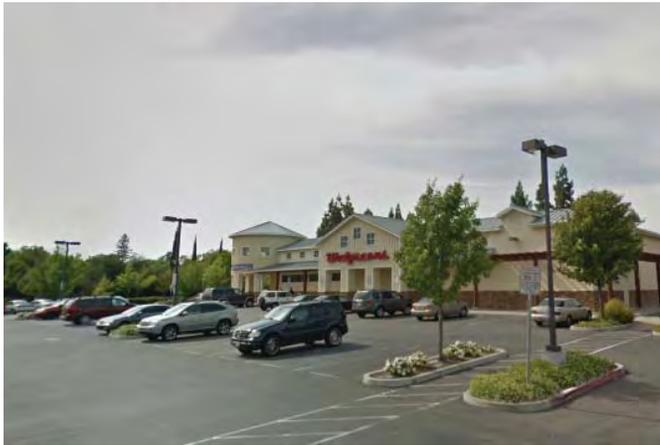
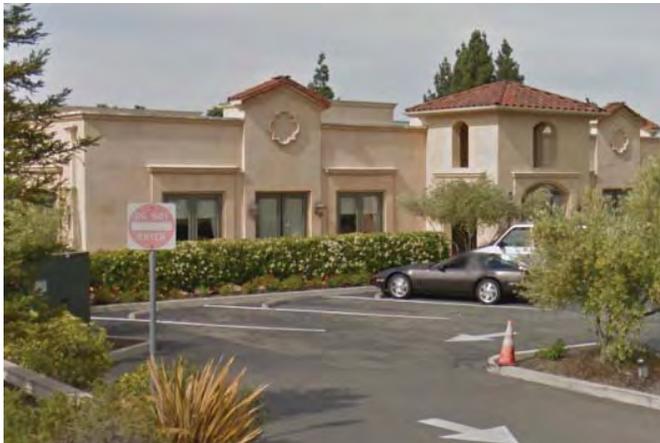
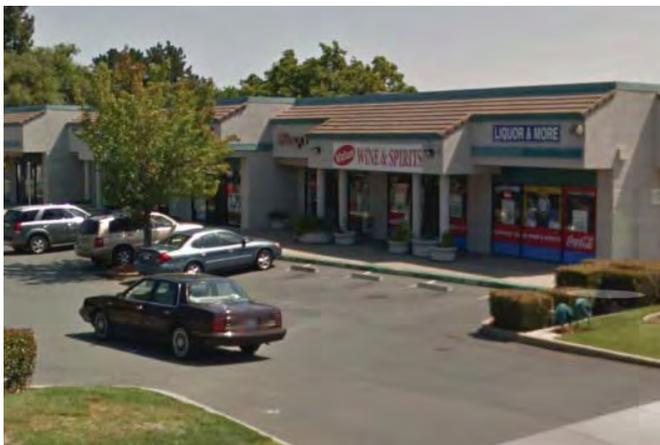
Tenant Signage: Walgreens incorporates both monument signs and wall signs and needs no attention. Zio Fraedos has no wall signs but uses well designed monument sign. Sandalwood tenants all have wall signs in varying states of repair and design. Sandalwood also seems to be utilizing generic temporary vinyl banners in a permanent manner.

Building Facades: Walgreens / Zio Fraedos: Great condition and design, no comment. Sandalwood is a strange and somewhat awkward combination of cinder block and green paint, but is also in good repair.

Paint: Good.

Storefronts: Fine for the most part. Sandalwood has too much window blockage.

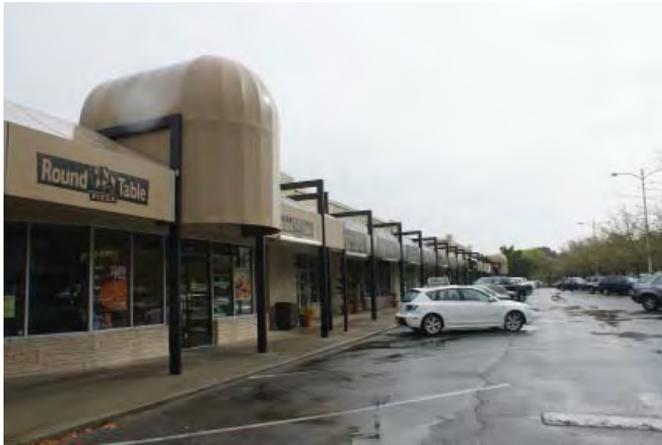
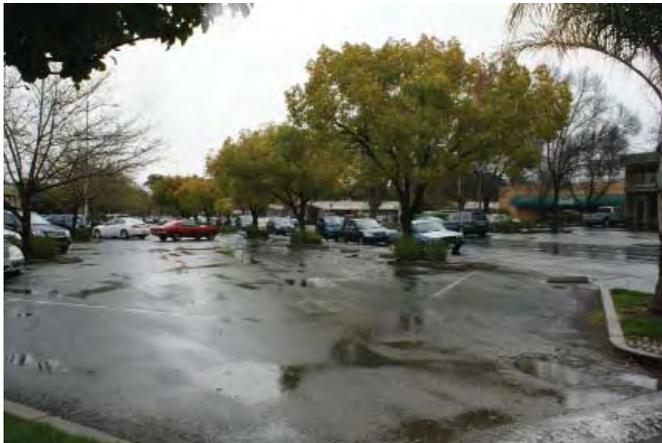
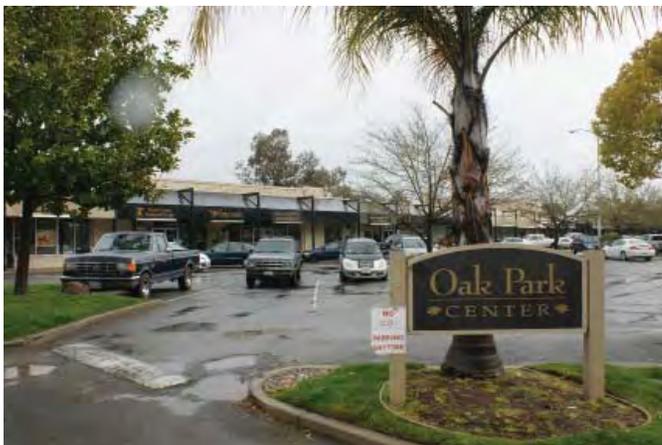
Building Facades: The underside of the overhang needs repair in places, the shake covered upper façade is missing shakes in places and the awning also needs repair.

Paint: Decent condition.

Storefronts: Uniform, boring and unvaried.

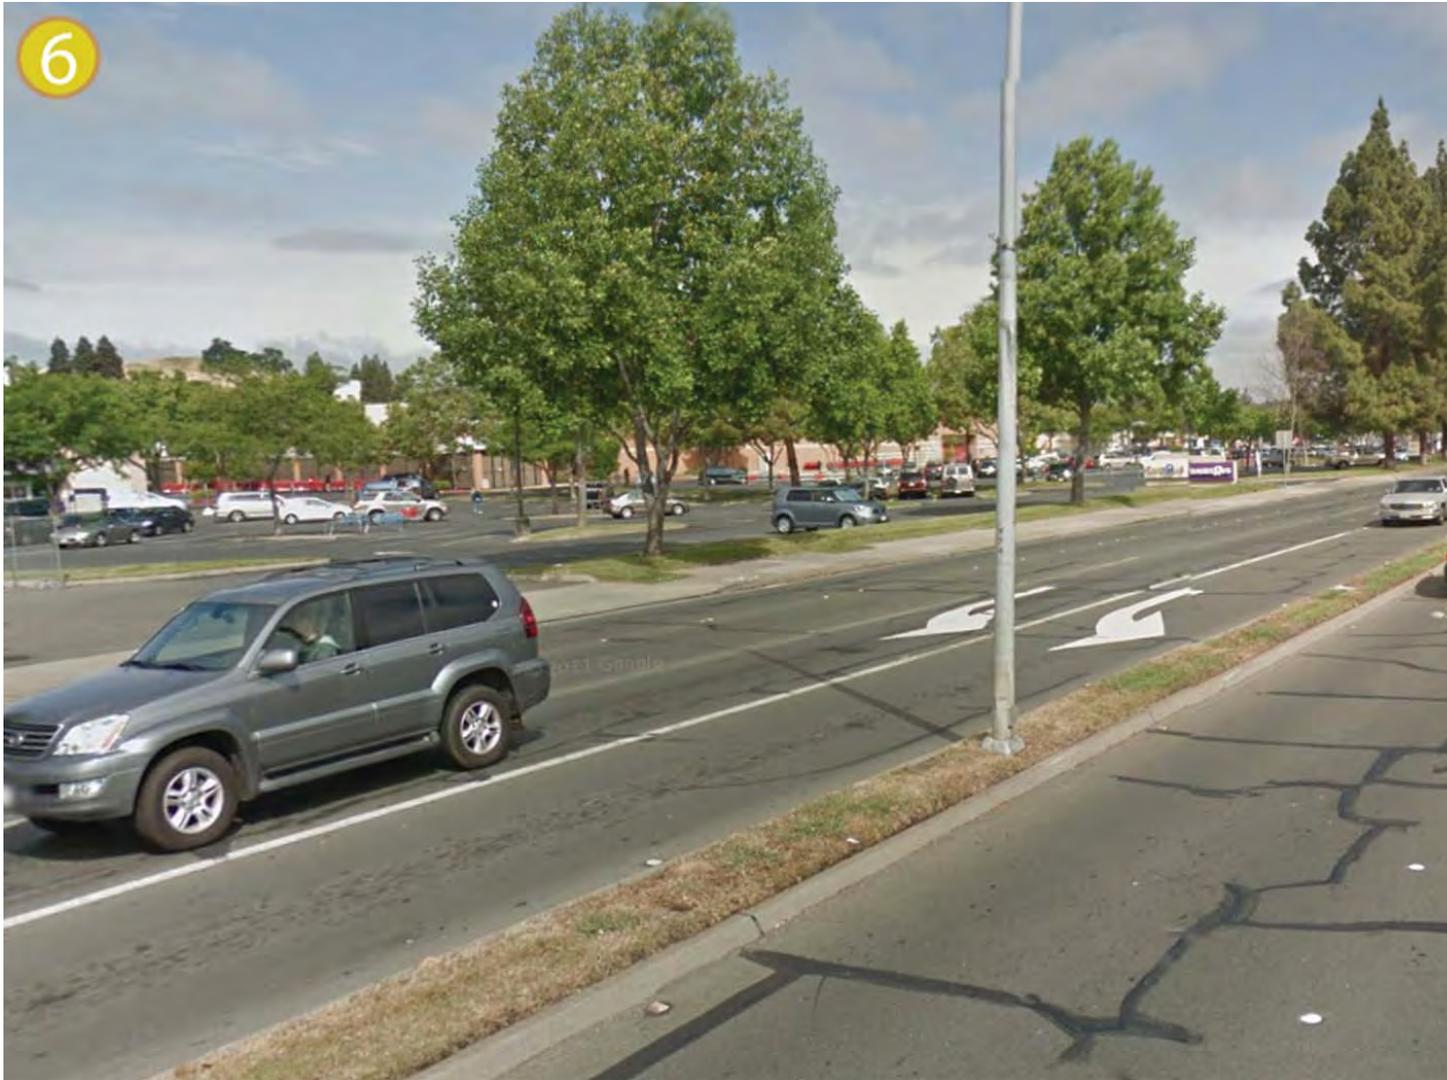
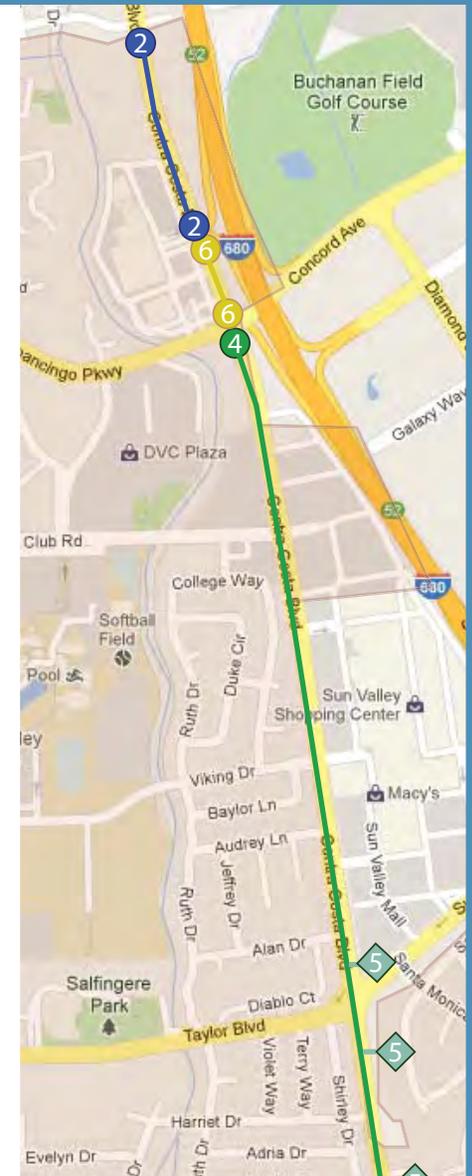
Median Type 6

Although relatively short, this section of median is the most undeveloped on Contra Costa Boulevard. Running from the Chilpancingo Parkway to Target, this portion of median contains only grass.

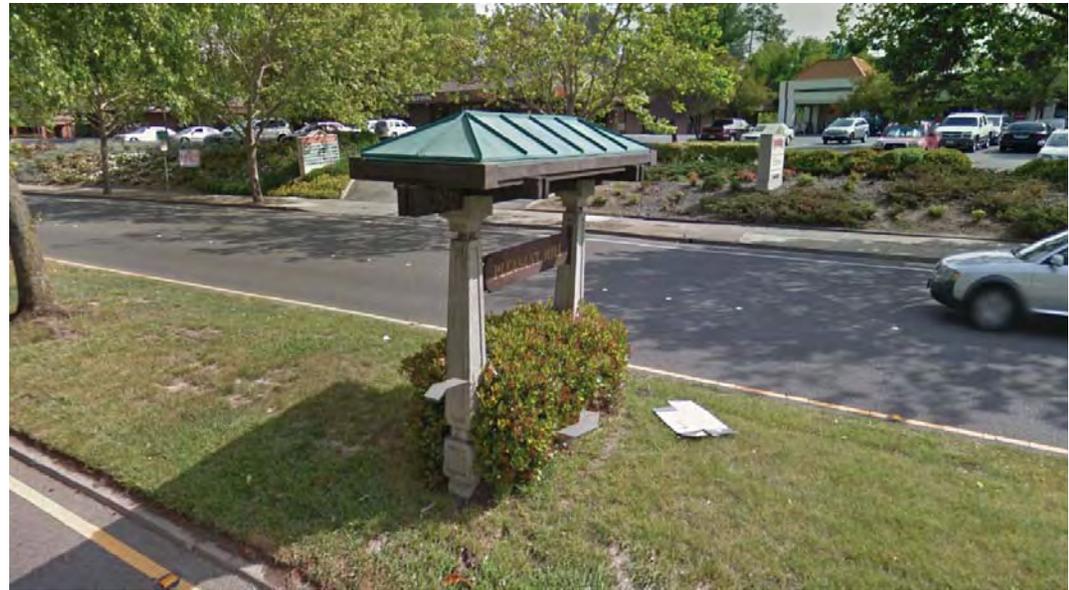
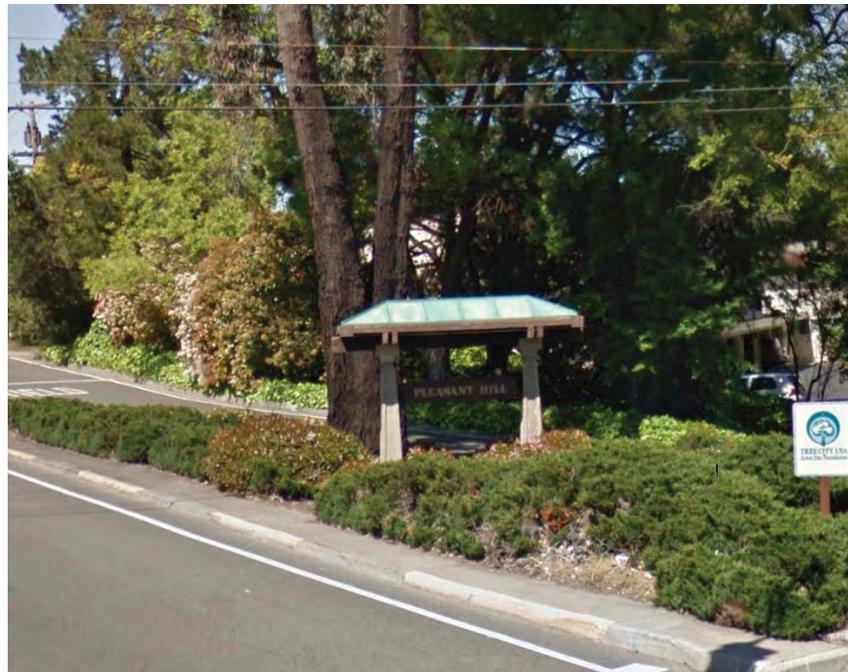
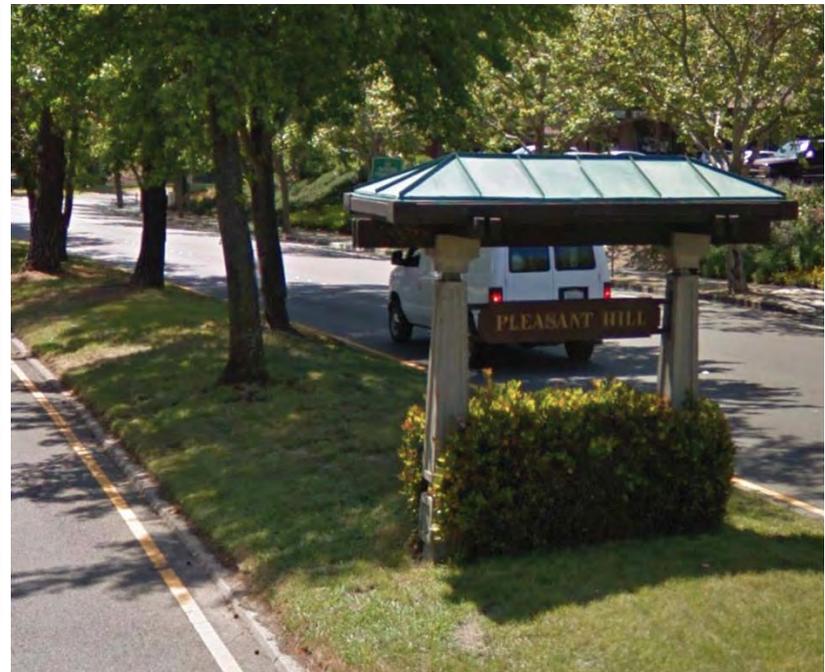
Current Gateway Monuments

Gateway monuments are an effective way of defining Pleasant Hill's distinct sense of place, acting as easily recognizable landmarks to aid navigation. Pleasant Hill currently has 11 of such monuments, but their upkeep and image needs updating.
